## Construction of Buildings in Soft Clay Deposits: A Case Study in a Public School in Florianópolis/SC, Brazil

In the present study, it is considered as a case study the structural condition of a public school (Anísio Teixeira Municipal School – ATMS) in the West Side region of the Costeira do Pirajubaé Massif, in Florianópolis/SC. The school is situated on a steep and densely urbanized slope. In 2019, beams and column breakages were found in classrooms and bathrooms at the school, which showed risk in its structure. From these data, it became relevant to develop a structural analysis of the school, through geological, geotechnical, and geophysical assessments.

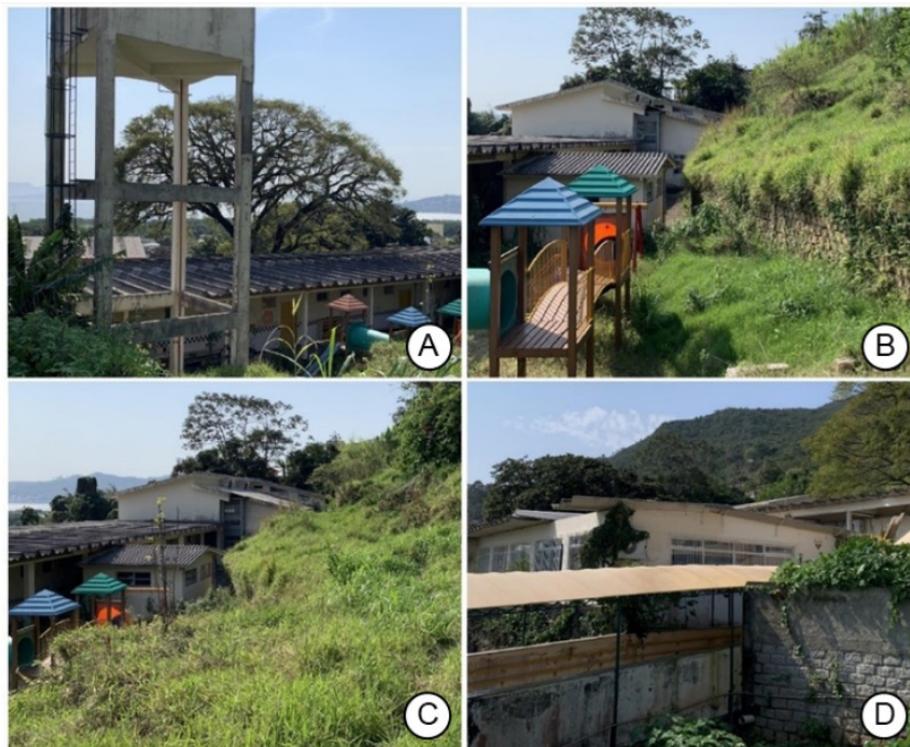
From the data collected, in the study area, it is observed the occurrence of colluvial deposits. It is verified the presence of rocky outcrops, in the form of blocks/boulders, upstream of the study area, and downstream, as slabs, blocks, and boulders. The area is located in a hillside environment (middle to lower third) with cuts and landfills resulting from human occupation, such as the construction of the school (Figure 3). In the upstream area, there is disorderly growth and housing with little construction technique (Figure 4). The occupation of this

**Figure 3** Anísio Teixeira Municipal School (ATMS - study area) inserted in the middle to lower third of the slope: A. Water tank and classrooms; B-C. Cuts and landfills resulting from human occupation with the aim of building the School; D. Walkway over the watercourse.

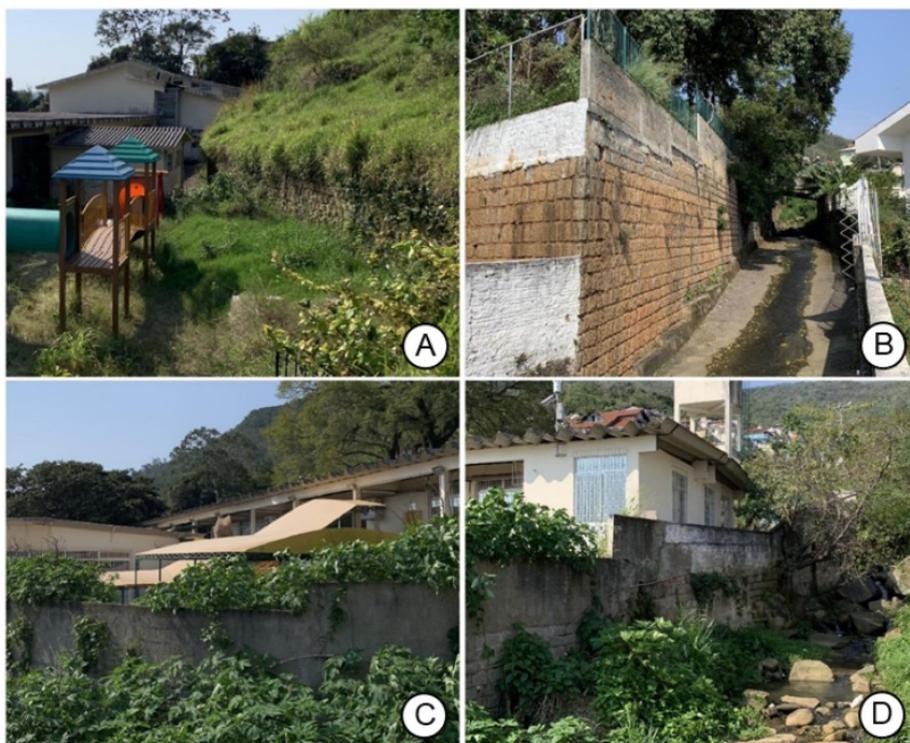
There are not efficient drainage systems in human interventions, nor efficient works to contain slopes. It is observed stone walls in some cuts made without an associated drainage system, some of them with the presence of water pouring (Figure 4B).

**Figure 4** Drainage and slope containment works are inefficient: A. Stonewall in some cuts made without associated drainage system; B. Stone wall with the presence of water pouring; C-D. Masonry wall without an associated drainage system.

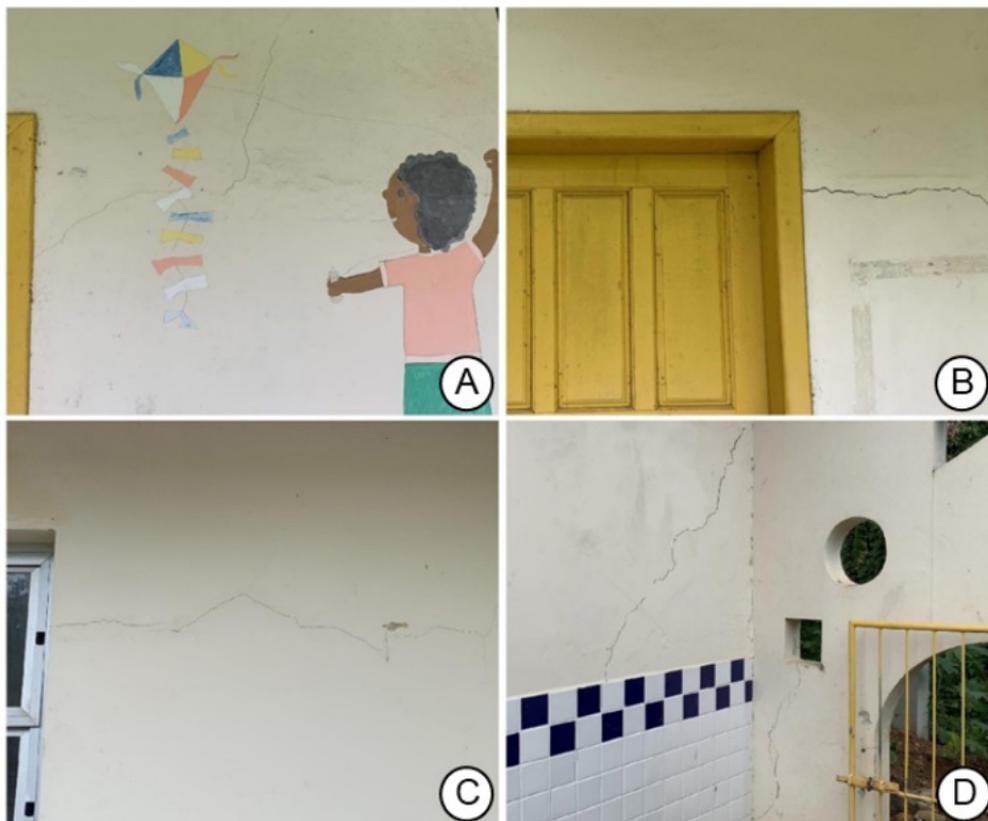
The ATMS has three classroom blocks distributed on the steep slope (Figure 1). In only two of them (1 and 2), the one upstream (Figure 5) and in the central portion (Figure 6), it is observed several cracks and fissures, as well as a possible rupture in the sidewalk located between the two aforementioned blocks (Figure 7 A-B) and the inclined trees (Figure 7 C-D).

**Figure 5** Upstream block (1) of Anísio Teixeira School: A. Inclined crack with a thickness of 0.5 mm; B. Horizontal crack with a thickness of 0.7 mm; C. Horizontal crack with a thickness of 0.4 mm; D. Inclined crack with a thickness of 0.6 mm.

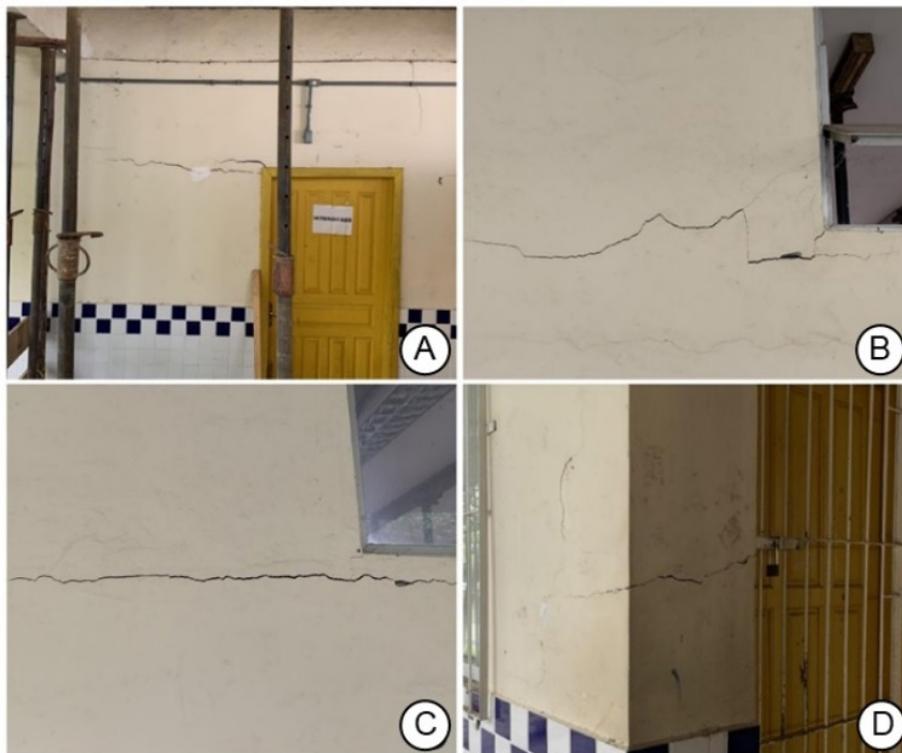
**Figure 6** Central block (2) of Anísio Teixeira School: A. Horizontal crack with a thickness of 0.7 mm near the door; B-C. Horizontal crack with a thickness of 0.6 mm near one of the windows; D. Horizontal cracks with a thickness 0.7 mm close to a door.

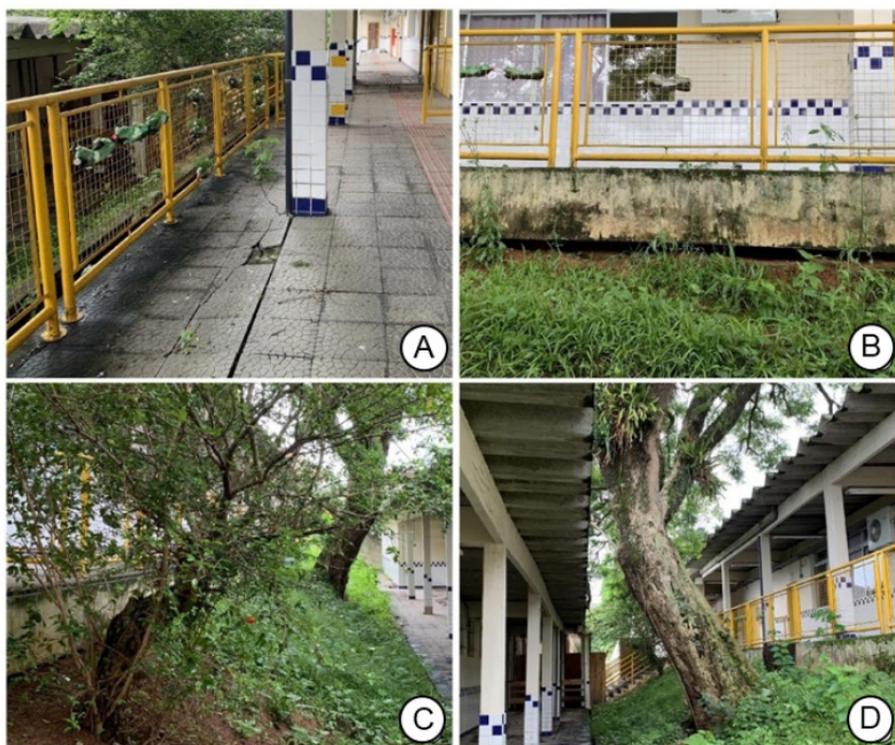
**Figure 7** Space between the most upstream and central block (1-2) of the Anísio Teixeira School: A-B. Sidewalk located in front of this classroom showing a possible rupture; C-D. Leaning trees showing a possible rupture.

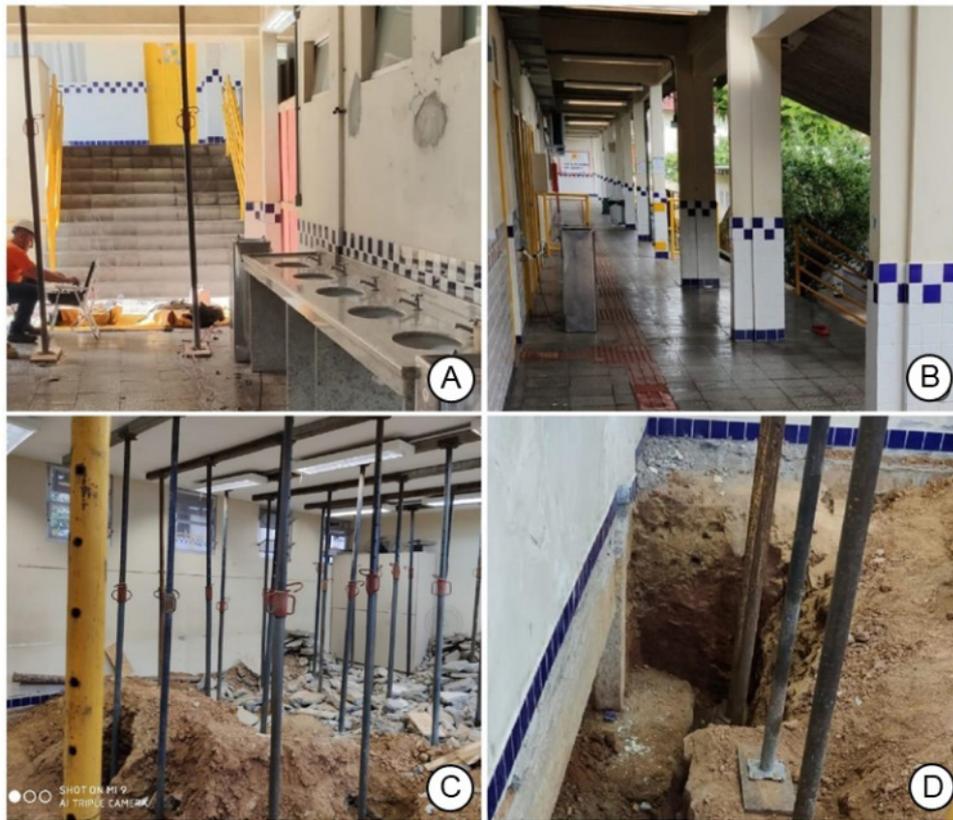
Another extremely serious finding is an excavation of approximately 2 meters, carried out next to a foundation pillar inside the classroom of the block that showed deterioration (Figure 8). In the area, it is noticed an empty space between the footing and the starting column, with no presence of water in this location, which is configured as the displacement of the footing (Figure 8D).

**Figure 8** Central block (2) of the Anísio Teixeira School: A-B. Several longitudinal cracks in the sidewalk located in front of this classroom show a possible rupture; C. Shoring throughout the classroom, allowing the evaluation of the severity of the rupture of the beams, and walls; D. Excavation of approximately two meters, carried out next to a foundation pillar inside the classroom of the block that showed the deterioration, in which an empty space was found between the footing, and the starting pillar.

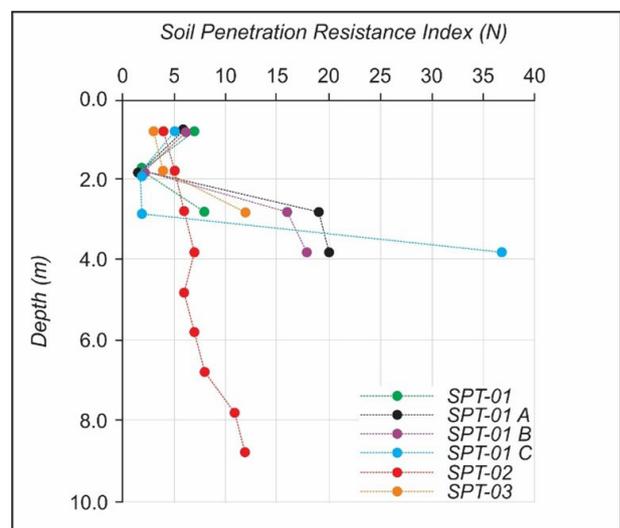
Regarding the Number of Blows (N), analyzing the SPT-1 and SPT-1A soundings, it was identified a low resistance layer, associated with soft gray clay, at an approximate depth of 2 m (2 blows), normally followed by a gain of resistance of up to 20 blows (Figure 9).

**Figure 9** Soil Penetration Resistance Index (N) graph of the SPT-01, SPT-01A, SPT-01B, SPT-01C, SPT-02, and SPT-03 soundings.

Still regarding N, analyzing the SPT-1B and SPT-1C soundings, it was identified a low resistance layer, associated with soft gray clay, at an approximate depth of 2 to 3 m (2 blows), normally followed by a resistance gain of up to 37 blows.

Finally, regarding the number of blows (N), analyzing the soundings, it did not find layers of low resistance, which could be associated with very soft gray clay, but a gain in resistance with depth, suggesting residual soil, according to the Figure 9.

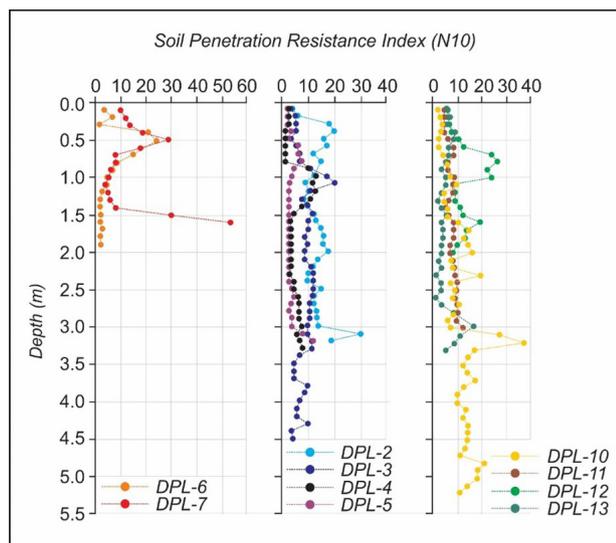
Figure 10 Soil Penetration Resistance Index (N10) graph of DPL-6, DPL-7, DPL-2, DPL-3, DPL-4, DPL-5, DPL-10 and DPL-11.

Regarding the Number of Blows (N10) of the DPL-6, at a depth of up to 1m, it is found a wide variation of the N10 (between 1 and 25 blows), as well as a low resistance layer (2 blows), normally between 1, 3 and 1.9 m. Differently, the DPL-7, presented at a depth of up to 1.7m, a wide variation of the N10 (between 4 and 54 blows).

The DPL-2, DPL-3, DPL-4, and DPL-5 (20 m elevation) (Figure 1), upstream of the classroom that presented the cracks (block 2), concerning N10, analyzing the soundings, no low resistance layers were identified, as shown in Figure 10.

Finally, in the DPL-10 and DPL-11 Penetrometric Soundings (18 m elevation), downstream of the classroom that presented the cracks (Figure 1), concerning the Number of Blows (N10), a tendency to gain strength with depth is identified (Figure 10). In the DPL-10, the water level was observed at a depth of 5.4 m.

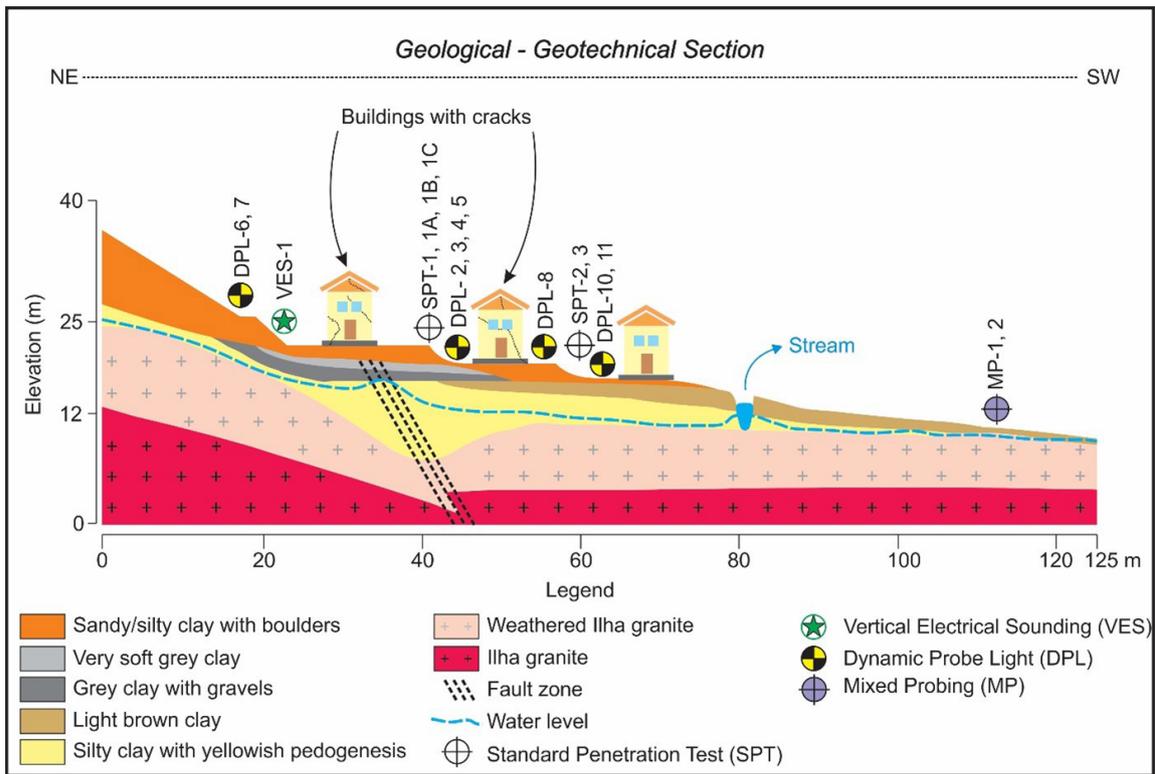
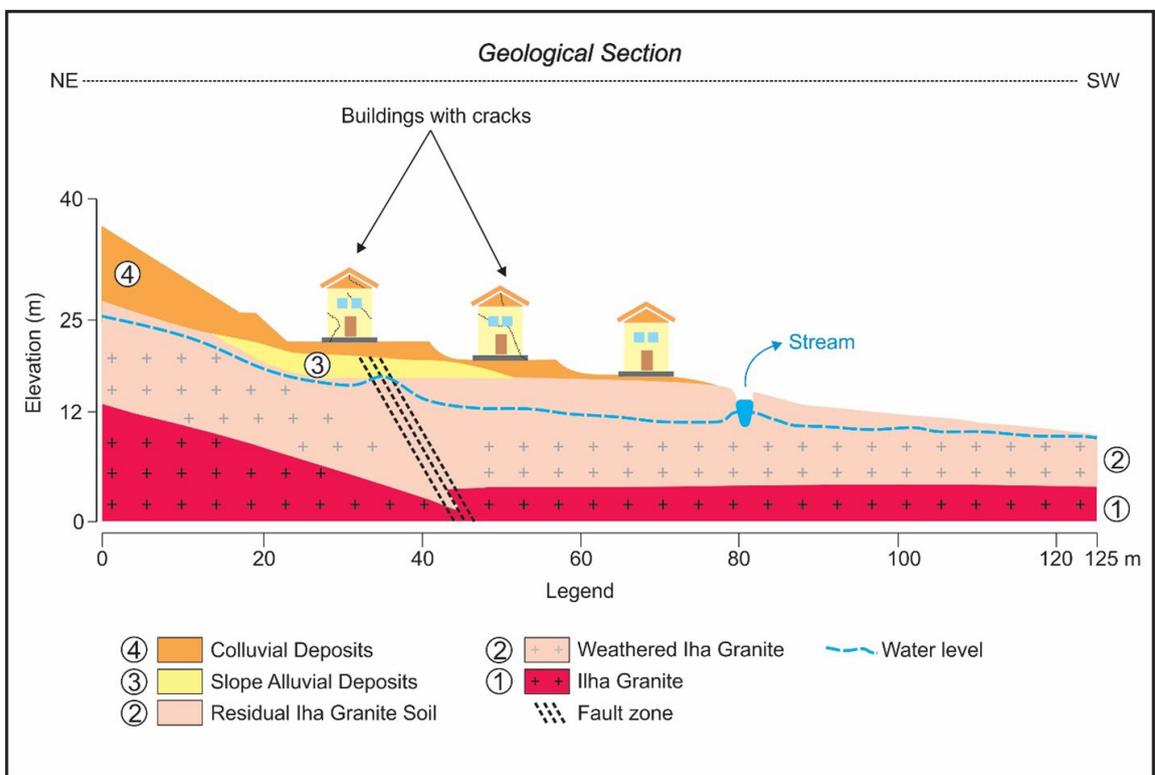
of k-feldspars in clay minerals. Analyzing the geological-geotechnical profiles (Figures 16 and 17), it was noticed that the rock layer is relatively shallow and sinuous. This morphology usually exhibits susceptibility to erosive flows with material carried underground, which, combined with the low maintenance of ATMS buildings (about 40 years of existence), are the cause of geotechnical problems.

The third unit, the Slope Alluvial Deposit (3), occurs locally below buildings 1 and 2 (Figure 17), which present the main geotechnical problems (cracks and displacement of shoes, ruptures, and leaning trees). This unit is composed of gray clays, very soft to soft, with the occurrence of rounded granules (pebbles are rare) in some layers. This unit has its genesis linked to sedimentation of continental origin, with deposition aided by a structural trap.

Therefore, it was observed the major geotechnical problems found in the ATMS (cracks and displacement of shoes, ruptures, and leaning trees) in buildings 1 and 2. These deformations are associated with the presence of layers of soft gray clay that occur on them. A similar situation was described by Andriamamonjisoa and Hubert-Ferrari (2019) in the urban area of Antananarivo (capital city of Madagascar). The very soft to soft gray clays found in the region of the study area (Martins 2021) have a high cohesion value, however, they have low friction angles, making them materials of low competence and low shear strength. This peculiarity causes the layer to undergo constant deformations caused by the stresses imposed by deposits and structures beneath it. This overload induces the loss of water between the clay particles, and the consequent soil compaction, giving conditions for the occurrence of deformations and geotechnical problems verified in buildings 1 and 2. Because the layers of soft gray clays are associated with a fault zone, the deformations can also be related to its reactivation. Therefore, this movement can generate small mechanical waves, which, when interacting with the clayey soil of the Slope Alluvial Deposit, would increase its pore pressures, enabling the formation of liquefaction processes. According to Kamal, Inel and Cayci (2022), the effect of neighboring buildings positioned on soft soils must be taken in count, since they can magnify
