Corrosion failures of austenitic and duplex stainless steels in a biodiesel plant

The neutralization of catalysts with hydrochloric acid is an important step in a biodiesel process which generates steel corrosion due to the decrease in pH, and the addition of chlorides in the medium. Other factor responsible for corrosion and consequently failures is the poor miscibility between biodiesel and acid water generating a heterogeneous coverage of the surface of the pipelines and equipment by biodiesel and acid water, presence of galvanic cells and localized corrosion. In this paper, corrosion failures of AISI 316L and 904L austenitic stainless steels (SS), and of SAF 2205, 2507 duplex SS in a biodiesel plant were identified and studied. The low pH, presence of chlorides, high thermal input in welding, temperature gradient and mainly proximity to the acid injection site play the major roles in corrosion which generate the studied failures. Corrosion failures occurred in pipes transporting biodiesel and acid water, in a spool of acid water injection, in a static biodiesel mixer with acidic water, in a cylindrical decanter vessel, and in heat exchangers.

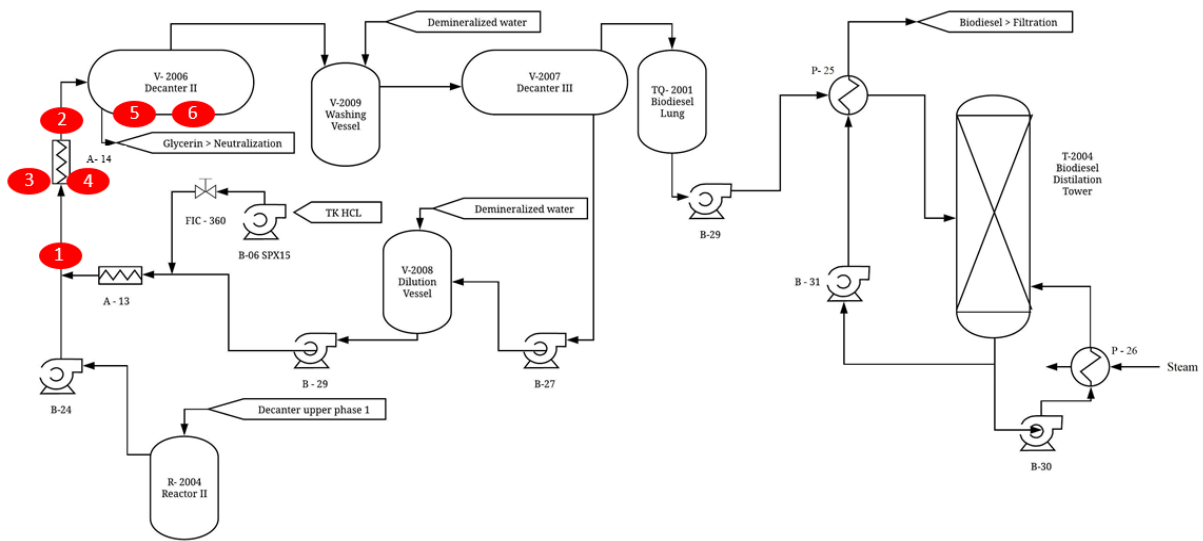
Figure 3 identified the failures which occurred in circuits of biodiesel. In the biodiesel circuit, four failures (numbers 1, 2, 3, and 4) were identified before and after the A-14 mixer and were associated with the acid dosing system. Miscibility between biodiesel and acid water is poor. When the acid water stream enters the pipe, the pipe surface was wetted with biodiesel and comes in contact with acid water in some areas, creating electrochemical cells with different potentials. Failures 5 and 6 occurred in a decanter vessel in biodiesel circuit (Fig. 3).

Figure 3: Identification of failures in the flowchart of the biodiesel circuit.

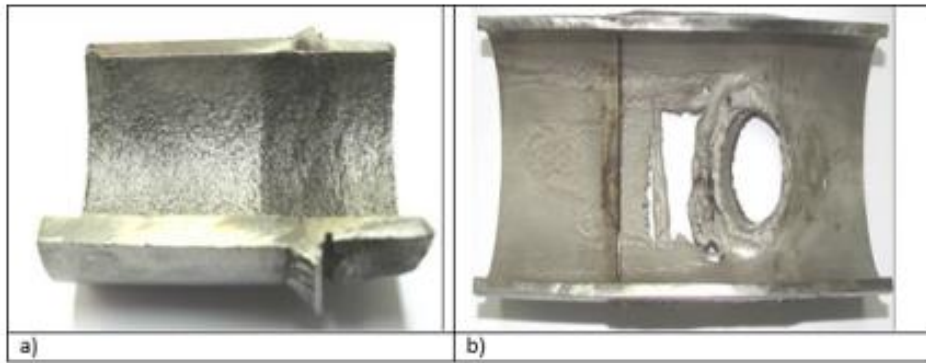
The failure number 1 (Fig. 4a) occurred after 23 months of plant operation, in a welded pipe of AISI 904L (25.4 mm in diameter) which transports acidic water with 1.5-2.0 vol. % hydrochloric acid in the biodiesel plant. The conditions of medium were pH between 3.0 and 4.0, temperature at 69°C, and mass flow between 575 and 950 kg/h. The failure characteristic was a loss of metal resulting in pass-through (hole) adjacent to the weld bead (fitting) of the pipe assembly, with loss of tightness. The morphology of acid corrosion was a pitting corrosion, and crevice corrosion (region of welded joint). The main failure causes identified was welding procedure with high thermal input, and lack of sealing of the weld fitting point, forming a crevice region. The high thermal input may have caused the grain growth near the welding bead, a region that has become cathodic; the anode being the region farthest from the welding bead with smaller grains [17].

According to critical crevice solution (CCS) theory, the initiation of active crevice corrosion involves the development of a deaerated, acidic solution within the occluded geometry [18]. Oxygen reduction usually occurs in aerated area, external to the occluded region, and metal dissolution occurs in the crevice region. Metal ions attract chloride ions, forming $FeCl_2$ which hydrolyzes generating hydrogen ions, acidifying the site, which also occurs inside the pits [17]. Metal ions from the steel dissolution such as Cr^{3+} can also undergo hydrolysis generating hydrogen ions [17]. Another possibility is the occurrence of concentration cell, in metals or metal alloys immersed in electrolytes, where the crevice region becomes saturated in metallic ions becoming the cathodic region [17]. Concerning to pitting corrosion, the pitting process progresses from pit initiation by passive film breakdown to early stages of pit growth: from metastable pitting to stable pit growth [19]. Frankel *et al.* [19] proposed that pit stability considerations are the controlling step of corrosion under aggressive conditions (harsh electrolytes and extreme environments and/or susceptible microstructures) and the passive film properties and protectiveness are the critical factors in less extreme environments and/or for less susceptible alloys. In this case, due to the nobility of superaustenitic steel (AISI 904L), which contains 24.57 wt.% Ni and 4.22 wt.% Mo, the controlling stage of corrosion can be the passive film breakdown. However, at this point of failure number 1, which is just after the entry of the acid water into the biodiesel stream, the corrosion was aggravated by the establishment of cells on the pipe surface which was wetted with biodiesel and started to present regions in contact with the acidic water.

Figure 4: Corrosion of pipe made of AISI 904L (a) and spool made of AISI 904L (b).

The failure number 2 (Fig. 4b) occurred after 29 months of operation in a spool of acid water injection, made of AISI 904L SS, 50.8 mm in diameter, in biodiesel stream. Fluids in contact with the equipment were biodiesel, and acidic water (1.5-2.0 vol. % HCl), at 69°C, pH of 3.0-5.5, and mass flow of 8.5-15.0 t/h. Loss of metal occurred resulting in the pass-through (hole) in the pipe wall downstream of the insertion of the neutralization stream, and adjacent to the weld bead of the pipe assembly. Morphology of acid corrosion was generalized, and localized at the welded joint, accelerated by the high chloride ion concentration gradient due to the heterogeneity of the flow in the region. Inefficient configuration (diagonal geometry) of the neutralization current insertion spool in the biodiesel stream was identified. Mixer A-14 (Fig. 3) was not efficient for the complete mixing between biodiesel and acid water. The pH is not neutralized efficiently for the orthogonal and diagonal geometries used in acid dosing systems in biodiesel plants even at 1.50 m the downstream point of insertion of acid solution [16]. Thus, even after the mixer A-14 (Fig. 3), chloride concentration gradients were still observed in the regions close to the pipe wall. The chloride concentrations remain high on the walls of the orthogonal and diagonal geometries in a long straight direction on the same side of acid injection [16]. Some regions of the tube remain wetted with biodiesel containing low chloride concentration and others were into contact with acidic water with high concentration of chloride. The diagonal geometry used in acid dosing system presented evidence of a weak mixture between the polar and non-polar species, even under turbulent flow as reported by Ferreira et al. [16]. The elbow geometry is more effective to reduce the local corrosive attack compared to two other simulated geometries [16].

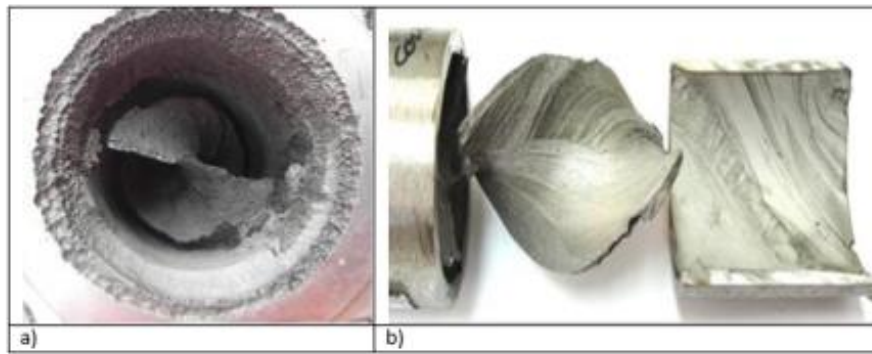
The failure number 3 was detected in a static biodiesel mixer with acidic water shown in Figure 5a. The function of equipment is to mix the mainstream (process biodiesel) with a load of hydrochloric acid. The mixer was fabricated with a shirt of AISI 316L SS with an internal side in SAF 2205 stainless steel. The process parameters were temperature at 64.0°C; pH from 4.0 to 6.0; mass flow of 104 kg/h. Failure was caused by severe weight loss. The detection mode was performed by inspection routine (internal visual). The failure mechanism was of electrochemical corrosion in an acid medium accelerated by the operating conditions of the mixer which provide the unremitting removal of the metal ions generated on the metal surface. The root cause detected was ineffectiveness in the acid dosing system (control), and the consequence of failure was operational efficiency loss. The acid medium containing chlorides, the process temperature above the room temperature, the fluid turbulence contributed to the corrosion of steel. But the fact that the steel was in contact with a heterogeneous fluid, being regions of the surface of the equipment in contact with the biodiesel and other regions in contact with the acid water accelerated the process and generated the mass loss observed [16].

Figure 5: Corrosion of a static biodiesel mixer with acidic water (a), and corrosion of a static mixer made of AISI 316L SS with an internal helical made of SAF 2205 duplex steel (b).

The failure number 4 (Fig. 5b) occurred in a static mixer made of AISI 316L SS, 50.8 mm in diameter, with an internal helical made of SAF 2205 duplex steel. The function of equipment is to mix the acid water and biodiesel. The mass flow of fluid is 6.0-11.5 t/h, pH 4.5-6.5, at 69 °C. Failure occurred after 29 months of operation. Corrosion was in an acid medium, with characteristics of the forms generalized and crevice corrosion (between the jacket and the internal helical). Mechanism of crevice corrosion was discussed earlier. The main cause of this failure was ineffectiveness of the acid dosing system; therefore, reduction of efficiency occurred with an increase of specific consumption of catalyst. Again, due to the heterogeneity of the fluid, part of the equipment encountered the apolar biodiesel fluid and part of the surface of the equipment was in contact with the polar acid water, of lower pH and with a higher concentration of chloride ions as described by Ferreira et al. [16].

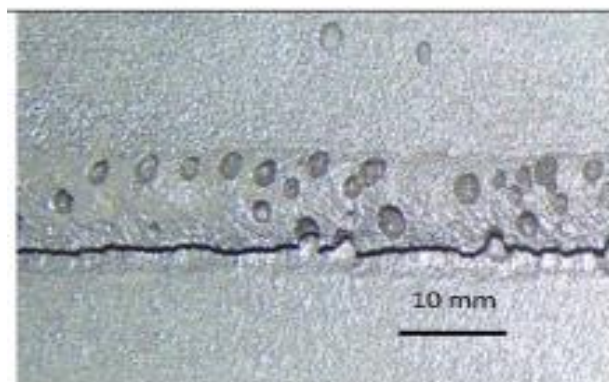
The failure number 5 (Fig. 6) occurred, after 62 months of operation, in a cylindrical decanter vessel, with a diameter of 2.286 mm, 7.94 mm in thickness, with rounded tops, made of AISI 904L SS. The function of this equipment is to separate the biodiesel and glycerin phases downstream of the second reaction. The bottom phase was acid glycerin, and the top phase was biodiesel, at 69 °C, pH of 1.5-2.0 (lower phase), and mass flow of 6.0 - 11.5 t/h. Loss of metal resulted in the discontinuity adjacent to the weld bead of the vessel in the inferior generator of the equipment (acid phase). Corrosion was in an acid medium, with characteristics of alveolar forms concentrated in welding bead. One identified cause is a less noble consumable used, an alloy with 22 wt.% Cr and 7 wt.% Ni, in relation to the AISI 904L steel, which contains 19.99 wt.% Cr and 24.57 wt.% Ni. Corrosion in boundary region of welding bead identified in Fig. 7 was probably due to the chemical composition difference between the consumable and the base metal. Ineffectiveness of the acid dosing system, and production halts without proper acid phase drainage also contributed to the corrosion damage. Fragility of the equipment with reduction of its useful life was a consequence of this failure.

Figure 6: Corrosion of a cylindrical decanter vessel.

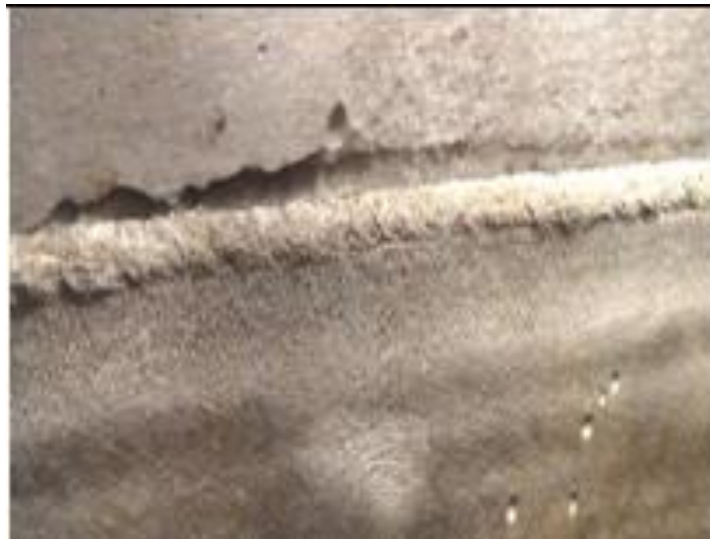
The failure number 6 (Fig. 7) occurred in the same equipment of failure 5, after 83 months of operation. Loss of metal (up to 3.1 mm) was identified in the lower generators of the vessel, especially in the re-

gions adjacent to the assembly welds, resulting in a reduction of the maximum allowable working pressure of the equipment. The corrosion in an acid medium was generalized, alveolar in base metal and in the welded joint. The generalized corrosion was consequence of harsh environment of pH 1.5-2.0 with chlorides. The localized corrosion observed in base metal was consequence of the ineffectiveness of the acid dosing system, and production halts without proper acid phase drainage.

The biodiesel received the acidic water and passed through the static mixer. But due to the inefficiency of the mixture, biodiesel enters the decanter as a two-phase fluid, an apolar biodiesel phase and a polar phase of acid water. In the decanter, the bottom contains glycerinated water and the top contains the heterogeneous mixture of biodiesel and acid water. Routine inspection equipment (internal inspection) identified this problem. Fragility of the equipment with reduction of its useful life occurred. Comparing failures 1 and 2 of AISI 904L SS in media of pH between 3 and 5.5 with failures 5 and 6 of AISI 904L SS in media of lower pH (1.5-2.0), we can conclude that these failures occurred due to a great number of variables and conditions in complex systems where sometimes pH does not play a major role. Time to failure was 23 and 29 months for failures 1 and 2, and failure time was 62 and 83 months for failures 5 and 6 where the steel was exposed to a more aggressive media of pH as lower as 1.5. Failure 1 represents a localized corrosion of AISI 904 steel in acid water of a higher pH than fluids associated to the failures 3 and 4 but showed the lowest failure time due to the greatest proximity to the acid injection site. In this case, the fluid provides the occurrence of steel surface regions wetted with biodiesel and regions wetted with acid water. In addition to this new parameter, the mechanism operating is very studied and involves formation of a passive film, breakdown of the passive film, growth of metastable pits which can re-passivate and growth of stable pits [20-22]. Stainless steels in acid solutions containing chlorides are quite prone to pitting attack [23].

The acid environment results in the destruction of the film layer and severe pitting formation [22]. Low pH value of solution decreases the impedance of the film and increases the OH⁻/O₂⁻ ratio leading to more severe pitting corrosion [22]. The presence of welding in equipment aggravates the corrosion problems due to the possibility of occurrence of corrosion cells in the regions with different grain sizes, galvanic cells due to the difference in the composition of the consumable and the base metal, aeration and concentration cells caused by crevice, but the objective of this work is to emphasize the effect of the inefficiency of mixing the biodiesel with the acid solution in the corrosion failures.

Figure 7: Corrosion in a cylindrical decanter vessel in the lower generators of the vessel, especially in the regions adjacent to the assembly welds.

In the biodiesel plant, AISI 304 SS was substituted by AISI 316L SS, due to the corrosiveness of medium. A recommendation is the use of nobler materials such as AISI 904L SS, duplex steels, or nickel alloy in critical points of process, such as the region of A-14 mixer and V-2006 second decanter in biodiesel circuit and the region of P-28 heat exchanger in glycerin circuit. However, this work alerts that the material specification is not sufficient to prevent corrosion failures. Technical requirements and improvements of welding procedures and acid dosage system are highly recommended such as the substitution of the diagonal geometry of acid injection by the elbow geometry by using an emissary tube.

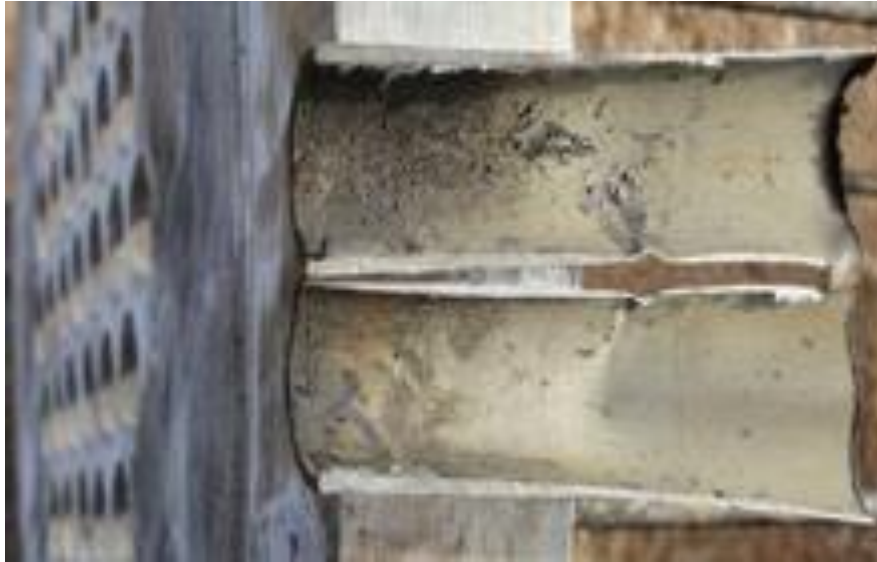
Failures 7 and 8 occurred in glycerin circuit were associated to the temperature effect. The failure number 7 analyzed occurred in a shell and a SAF-2507 tube heat exchanger which raises the temperature of glycerin to 95°C (Figure 8). On the cold side, the fluid was processed glycerin with 25 wt.% H₂O and 7 wt.% NaCl, and on the hot side the fluid was 10.0 kgf/cm² steam. The process parameters were pH of 4.5 to 5.5; mass flow rate of 40 t/h. The glycerin temperature (cold side) was 60°C (input) and 95°C (output). The failure mode was corrosion with significant reduction of thickness of the tubes mainly in the hot side immediately

below the mirror as shown in Fig. 8. In thermogalvanic cells, the anode is usually the hot region. According to the Nernst equation, an increase in temperature reduces the reduction potential of a half reaction [17].

Thus, the cold region with a higher reduction potential is usually the cathode in this cell [17]. The detection mode was equipment inspection routine (thickness measurement technique by IRIS - "Internal Rotary Inspection System"). The failure mechanism was electrochemical corrosion in an acid media, accelerated by the temperature gradient along the tube (thermogalvanic cell). The ineffectiveness of acid dosing system (control) and high concentration of catalyst also contributed to this failure. The consequence of failure was the equipment campaign reduction.

Figure 8: Corrosion in a shell and a SAF-2507 tube heat exchanger which raises the temperature of glycerin to 95°C.

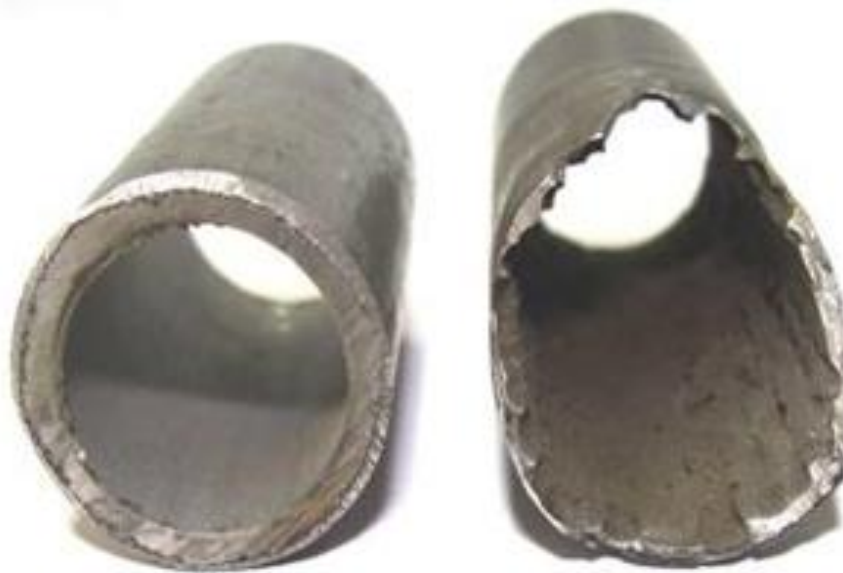
The failure number 8 was identified, after 54 months of operation, in a hull and tube type heat exchanger. The tubes are made of SAF-2507 steel, with diameter of 19.10 mm and thickness of 2.10 mm, which function was to increase the glycerin temperature from 69°C to 95°C, at the distillation stage, as shown in Fig. 9. Process glycerin contained 25 wt.% water and 7 wt.% NaCl, at 95 °C, pH of 4.5 - 5.5, and mass flow rate of 40 t/h (recirculation). Communication occurred between the phases of the exchanger caused by passing discontinuities (holes) in the pipes. The corrosion morphology was generalized and alveolar shape, accelerated by the significant temperature difference in the tubes, in the region near the mirror (thermogalvanic cell) [24]. The inefficiency of the acid dosing system, and high catalyst ratio also produced the corrosion failure, but this cause was more relevant in the biodiesel circuit. This failure was detected by process follow-up routine and leak testing. Contamination of the condensate system with unplanned shut-down caused loss of production.

Figure 9: Corrosion in tubes of a hull and tube type heat exchanger.
