# Mapping Atmospheric Corrosion as a Heritage Management Tool in Oaxaca, Mexico

Marco Hernández-Escampa<sup>i</sup>

**Abstract:** Archaeometry is the application of Natural Sciences techniques, including Geography, to solve problems in Archaeology and Heritage Conservation. Corrosion constitutes the main deterioration process of metals, which is triggered by the properties of the surrounding matrix. This work focuses on atmospheric corrosion in Oaxaca, Mexico. Methods used included the creation of atmospheric corrosion stations where weight loss was measured and geo-localization of archaeo-metallurgical heritage was determined in the study area. A brief historical review of the cultural importance of metals in Mexico is also treated. Results for the three first months of measurement showed that atmospheric corrosion values are higher in the city centre, where heritage is more concentrated. Air pollution and increased temperatures attributed to global warming are considered to be relevant for explaining the data obtained. Further analysis of a full year cycle is expected to reinforce this argument. The methods used are shown to be useful heritage and urban management tools applica

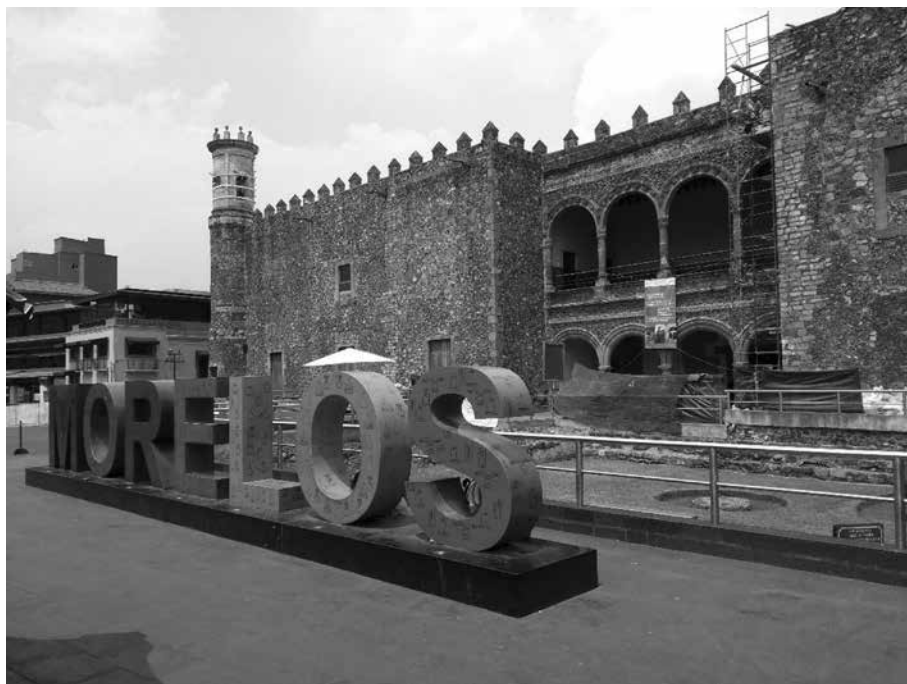
Figure 1 – The Hernán Cortés Palace in Cuernavaca, the capital city of Morelos State, was built during the 16<sup>th</sup> century. Mainly made of stone, it lodges a clock tower, which forms part of the city’s archaeometallurgical heritage. In the picture, the building was restored after the 7.1 magnitude earthquake that took place in 2017.

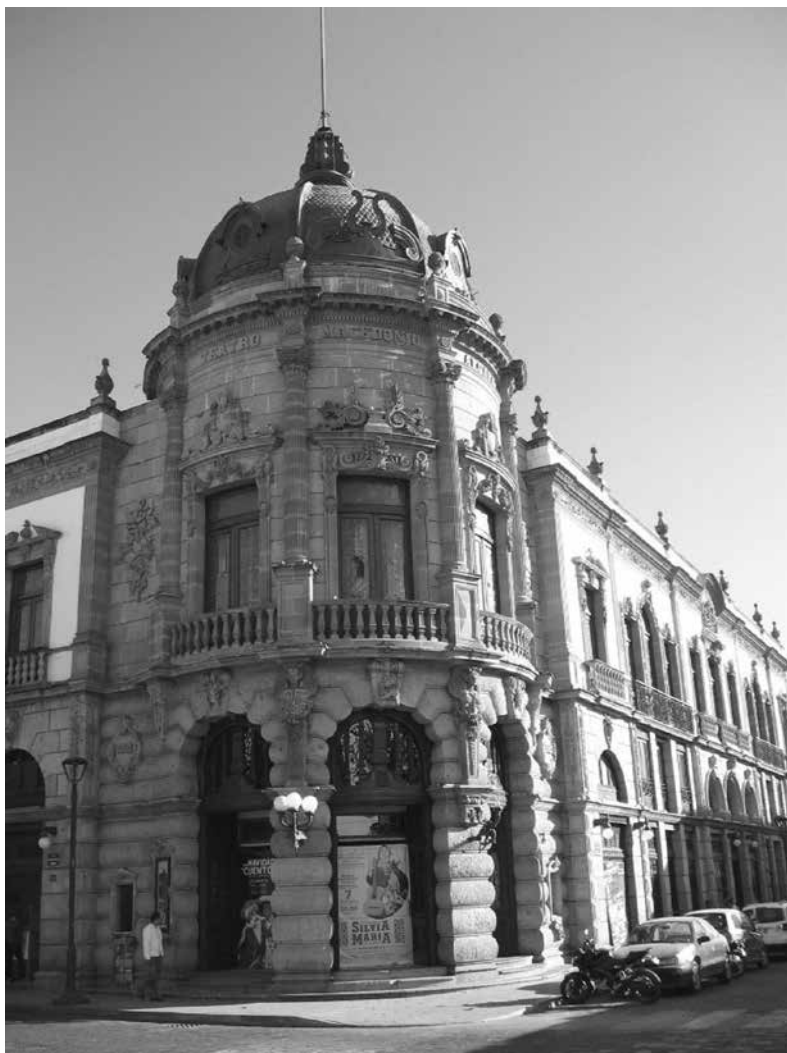
Figure 2 – Macedonio Alcalá Theatre in Oaxaca is an illustrative example of early 20<sup>th</sup> century architecture with metallic structural and ornamental elements.
