Technological Evaluation of Roof Tiles from the Monastery of São Bento, Rio de Janeiro

Centro de Tecnologia Mineral (CETEM), Rio de Janeiro, RJ, Brasil

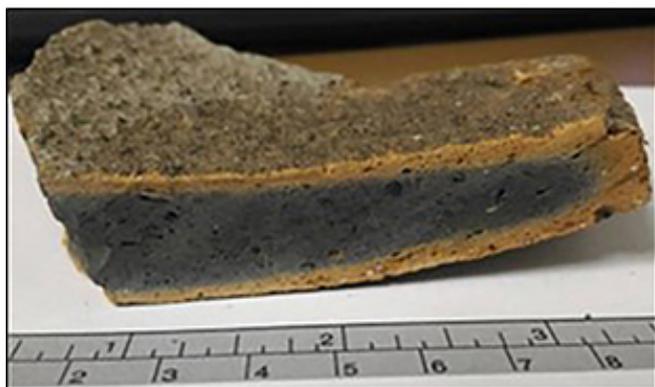
Figure 5 Macroscopic image obtained from a sample of roof tiles: A. Sample length; B. Sample thickness.

The macroscopic analysis, Figure 5, showed a sample thickness of around 0.4 to 1.5 cm, with a clear distinction of the ocher coloration in the external layer and the internal one showing a black color. The differentiation of such layers, in accordance with the results obtained in XRD, are represented in the external layer by quartz, potassic feldspar (microcline), mullite and gypsum and the internal layer represented by hematite.

The alterability of the roof tile outer layer was identified through the black gypsum crust formed by physical-chemical changes in the calcium present in the roof tiles in contact with the sulfur present in acid rain.

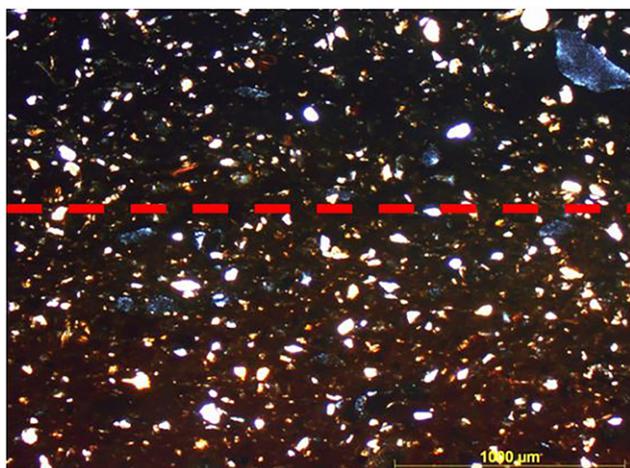
Figure 6 Microscopic image of roof tile sample.

The microscopy performed on the sample, Figure 6, enabled the determination of the inner and outer layers. The inner layer (black color) is composed of a fine matrix, in which submillimeter and millimeter angular grains are dispersed, mainly quartz, feldspar and opaque minerals (associated with hematite as identified in the XRD). The outerlayer (ocher color) is composed of a fine matrix, with quartz, and eventually feldspar, submillimeter angular crystals.
