# Distress Manifestation in Asphalt Pavements: Comparison between Local and Unmanned Aerial Vehicle (UAV) Measurements

*Manifestação de Defeitos em Pavimentos Asfálticos: Comparação entre a Medição Local e por Veículo Aéreo Não Tripulado (VANT)*

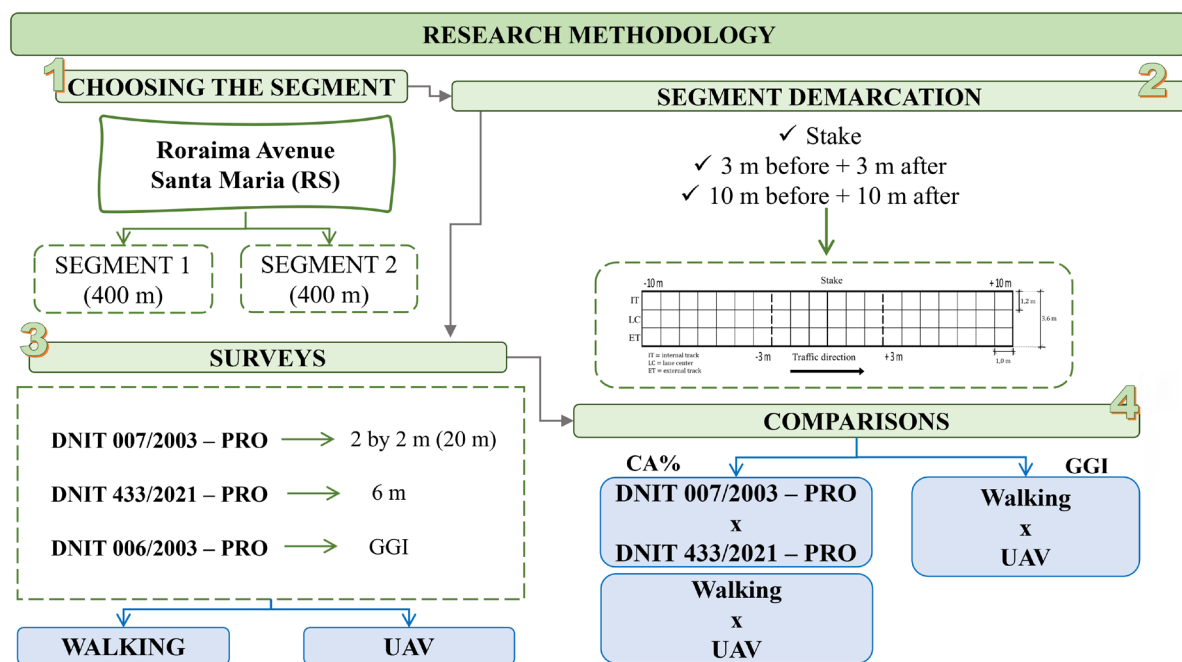
Figure 1 General outline of the research.

Figure 1 shows the general outline of the research, which has four main topics. The following sections will consider each stage: definition of the study section and demarcations, surface surveys, and comparisons between results.

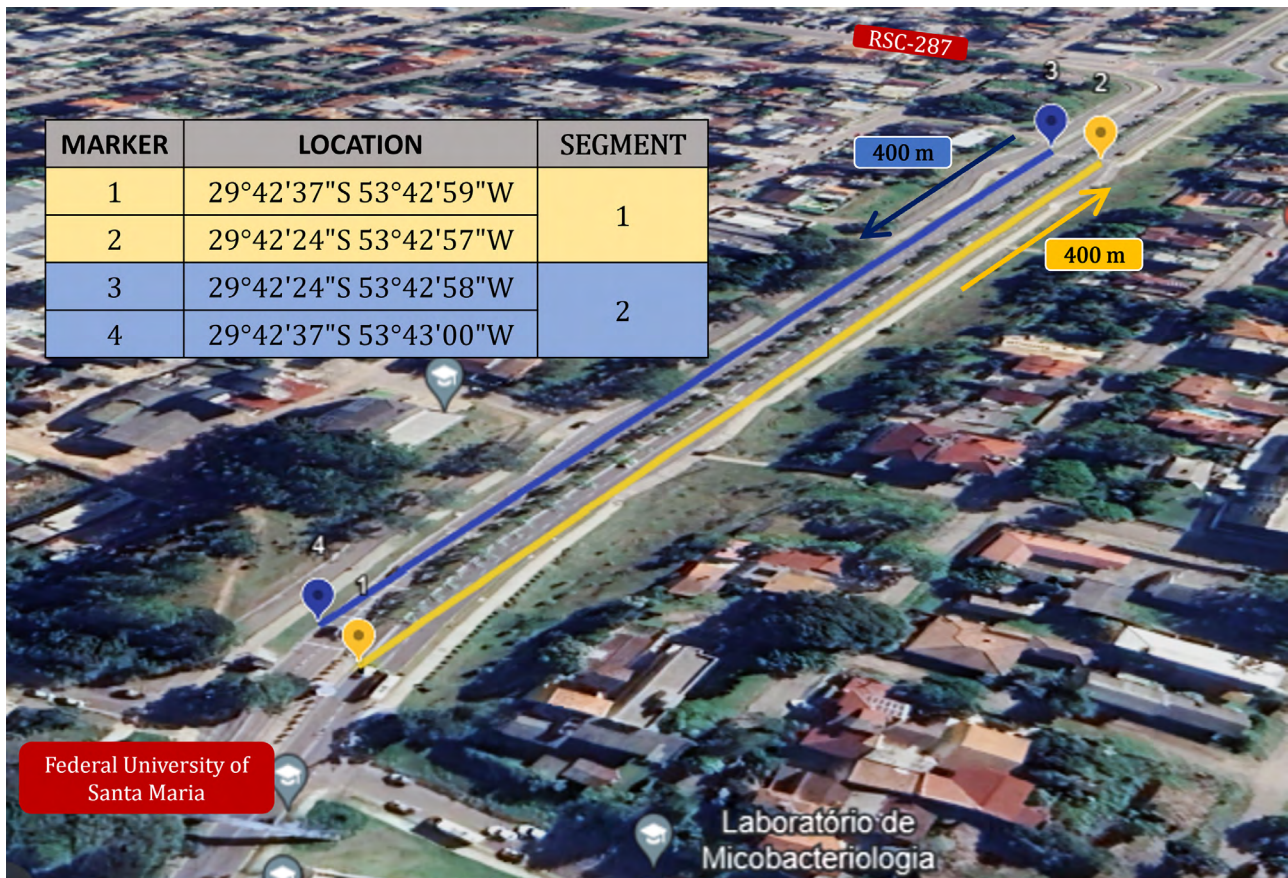
Figure 2 Location of the segment studied.

The road segment used as the basis for the study was Roraima Avenue, the access road to the Federal University of Santa Maria (UFSM) in Rio Grande do Sul (Figure 2). The stretch is made up of asphalt pavement, which was resurfaced in December 2012.

The chosen pavement segment for this study starts at the entrance to UFSM (Federal University of Santa Maria) and extends to the RSC – 287, as shown in Figure 2. The road is a dual roadway (each lane is 3.6 m wide), and the surveys were restricted to the most heavily loaded lanes (the right ones). Each segment extends over 400 meters in the first stretch (direction leaving UFSM), plus another 400 meters in the second stretch (direction entering UFSM), totaling 800 meters. Stake markings were added to the track every 20 m (starting 50 m from UFSM), totaling 20 stakes in each direction (Figure 3). The markings on the

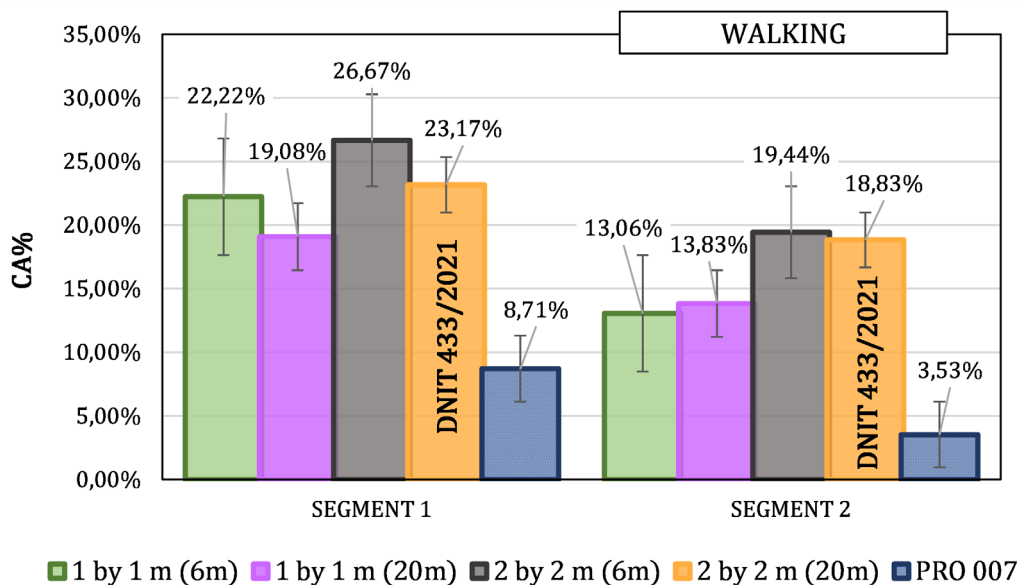
Figure 6 Average CA% values for standard DNIT 007/2003 - PRO and adaptations of standard DNIT 433/2021 - PRO.

Figure 6 shows the average CA% values. Since the 2021 standard is recent and still needs to be validated, attempts were made to adapt the protocol, in terms of the length of the section assessed and the longitudinal dimension of the cells. Therefore, 4 measurement methods

were tested: 2 methods on the entire stake (20 m), with cells measuring 1.2 m x 1.0 m and 1.2 m x 2.0 m; and 2 methods on just 6 m (from DNIT 007/2003 - PRO standard), with the same variation in cell dimensions.

In this sense, Figure 6 shows that the average values found by DNIT 433/2021 - PRO standard and its adaptations are higher, considering the standard error also shown in the figure. This standard, used by MeDiNa, would already warn of the need to restore these roads, while DNIT 007/2003 - PRO, also in current use in field practice, indicates that the pavement is in good functional condition in terms of cracking. However, it is worth noting that DNIT 433/2021 - PRO

In addition, as expected, the surveys in larger cells by DNIT 433/2021 - PRO provide higher average results compared to the 1 m cell at the corresponding station (6 or 20 m), since the presence of a crack compromises twice the area. However, the standard error bars indicate that the sampling variability does not allow one to confidently conclude that the averages found for the adaptations to DNIT 433/2021 - PRO standard are different. Therefore, surveys at each meter are not justified, as they are more time-consuming and laborious to carry out.

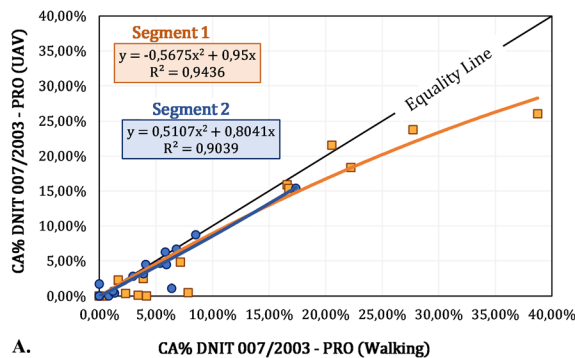
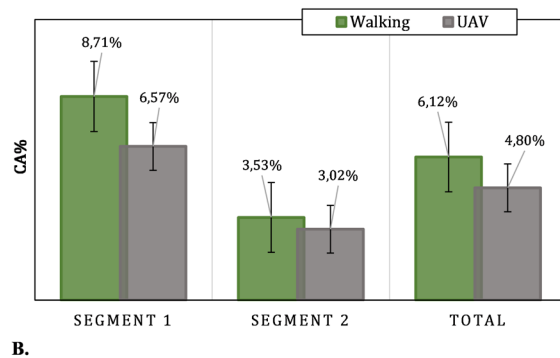
Figure 7 CA% DNIT 007/2003 - PRO (UAV x Walking): A. Per stake; B. Overall.

On the other hand, the quantification of the cracked area also differed according to DNIT 007/2003 - PRO protocol between walking and UAV. The values per stake (Figure 7A) show that the points are close to the equality line, especially for less than 20% cracked areas, as occurs in the second section. From this value onwards, greater differences were seen, especially as the first section (CA% up to 40%) had more FC-1 cracks (cracks with an opening of less than 1.0 mm), possibly not identified in the images, even though the equipment has high resolution. In addition to this factor, AutoCAD's area measurements are more precise than the tape measure survey, leading to lower CA% values.

The average CA% for all the stretches evaluated (total CA% in Figure 7B) that the UAV could only achieve 78% of the value found by walking. It is worth noting again that the biggest difference between the methods is in the first section, with the greatest presence of smaller cracks, which were not visualized by the equipment. To calculate the total percentage of cracked area, in order to make decisions about whether or not to carry out maintenance or restoration work on the pavement, the visualization of these cracks is relevant.

In addition, it is worth noting that although the standard error bars with 1 standard deviation around the mean (68% of the data within this range) suggest that there is statistical similarity, FC-1 cracks were not visualized by the UAV. For this reason, it is clear that strategic intervention planning cannot be based solely on average values or on pure statistical similarity, as identifying cracking at an early stage is important for more cost-effective interventions.

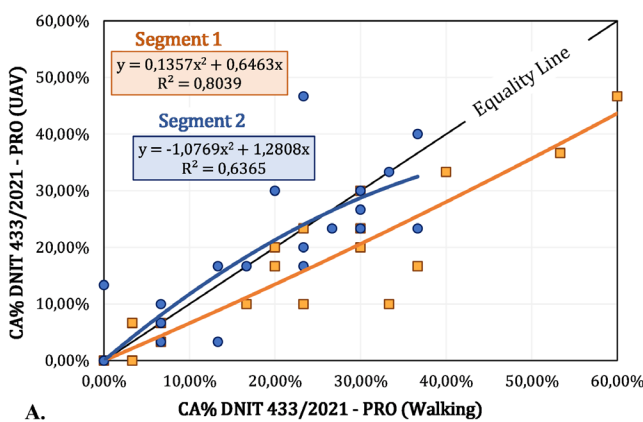
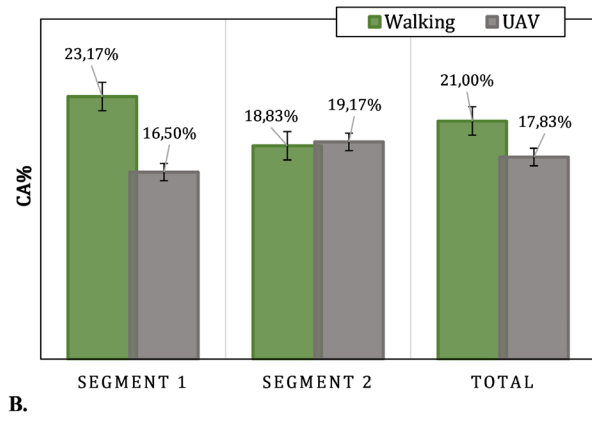
Figure 8 CA% DNIT 433/2021 - PRO (UAV x Walking): A. By stake and B. Overall.

The same occurred when the cracked area survey was carried out using DNIT 433/2021 - PRO standard. In this case, section 1 had points above or below the equality line, and the walking method tended to identify a more significant number of cracks (Figure 8A). For the second section, the points are more dispersed around the equality line, but no clear trend exists.

The average values (Figure 8B) indicate that the UAV method was inaccurate in the first section, as mentioned above because the images were not sensitive in identifying FC-1 cracks. This difference for the first section

was more significant than that found when comparing with DNIT 007/2003 - PRO standard.

In addition, the differences are also aggravated by the greater precision in tracing the cells when done via software. However, the results for the second section and the overall result showed that the use of the UAV obtained a cracked area similar to the walking method since the visualization of a single crack is enough to count the cell as affected. On average, this technique achieved 85% of the cracked area verified by walking according to DNIT 433/2021 - PRO standard. In this case, the standard error bars (considering 1 standard deviation around the mean) do indeed indicate a statistical difference between measurements by walking and by UAV. For the DNIT 433/2021 - PRO standard, the UAV provided a statistically similar result to walking only in segment 2. This observation confirms the UAV's limitation in observing cracks with an opening of less than 1.0 mm, which were more present in the first section. Once again, it should be emphasized that the assessment of the functional condition of pavements should not be based solely on average cracked area values, and the visualization of FC-1 cracks is necessary for planning interventions.

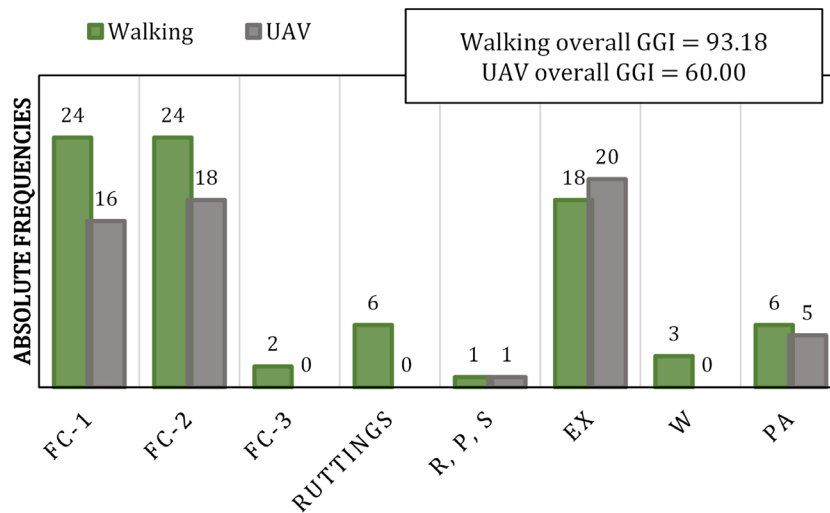
Figure 9 Absolute frequencies of distresses found by walking and by UAV.

Figure 9 highlights the differences in the absolute frequencies of distresses found by the two protocols, with the walking method identifying around 1.4 times more distresses. It is worth noting that the survey was similar when looking at distresses of exudation, ripples, potholes,

and slippage. The GGIs of the first and second sections were 114% and 18% higher than the UAV determinations, respectively. For the overall GGI, the walking method provided a 55% higher result.

When comparing the methods, it was again possible to see that the UAV was less efficient at visualizing cracks. This phenomenon can be explained by the technology used to capture the photographs, or the flight altitude chosen. Captures at lower altitudes, covering smaller portions of the stake, could lead to more accurate results.
