The Effect of Periodic Maintenance on Pervious Concrete Pavements

Rodrigo Garozi da Silva¹, Maria da Consolação Fonseca de Albuquerque¹,
Marcelo Bortoletto¹, Felipe de Almeida Spósito¹,
Aparecido Carlos Gonçalves², Marco Antonio de Moraes Alcântara¹

¹ Universidade Estadual Paulista, Department of civil engineering, Alameda Bahia, 550, CEP: 15.385-000, São Paulo, Ilha Solteira, Brazil.

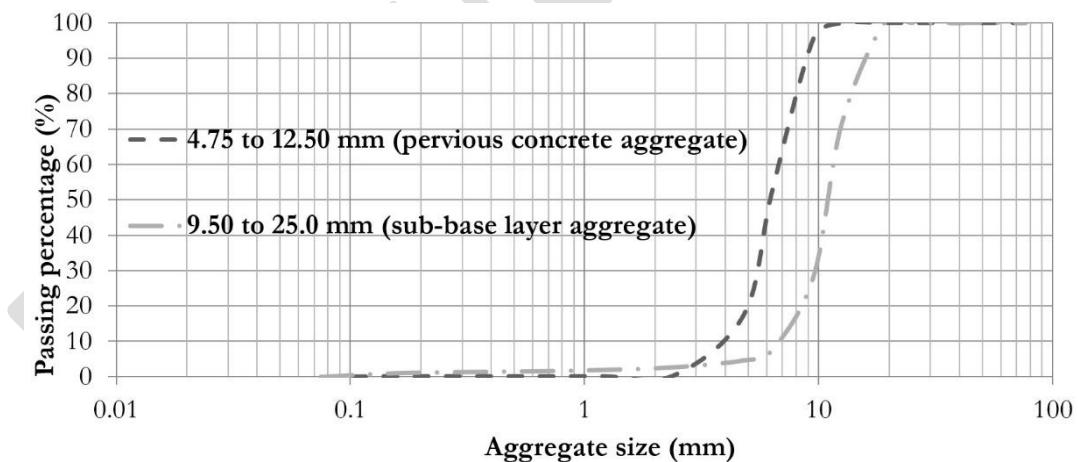
For the pervious concrete mixture, only crushed basaltic stone coarse aggregates were used, provided by Mineração Grandes Lagos in Itapura, State of São Paulo. The gradation range varied from 4.75 to 12.5 mm, as specified in NBR 7211 [31]. This aggregate gradation is close to that observed in the literature [3, 6, 11, 22]. For the sub-base layer, the same coarse crushed aggregates were used, but with a larger 9.5 to 25.0 mm gradation, according to NBR 7211 [31]. Figure 2 shows the gradation distribution of the aggregates used.

Figure 2: Gradation curves of coarse aggregate

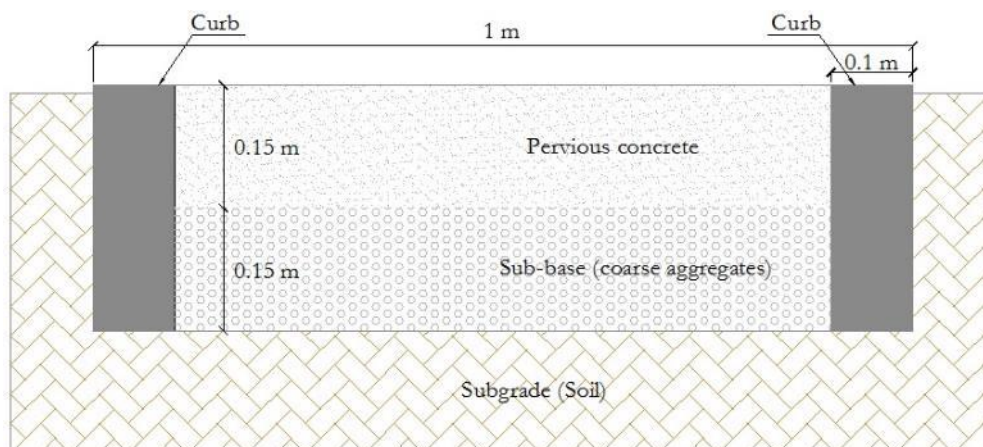
The first stage was delimiting the area and regularizing the soil. The site was excavated and the subgrade surface was only planed without receiving any compaction. Subsequently, a 10 cm thick perimeter curb was built around the sidewalk contour, delimiting the area for later placement. The sub-base layer of crushed aggregates was then placed, smoothed and moistened. Wetting the sub-base just prior to placement is necessary to prevent it from absorbing water from the concrete mixture [3]. The concrete was mixed and placed by a concrete mixer truck, provided by the Brambilla company. The top layer was spread and consolidated with a steel roll passed 3 times in a single layer, which provided the finish. The consolidation roller is approximately 61 kg with 1 m length. This roll is similar to recommended for consolidation and regularization by ACI 522R [42], with a proportional reduction in length in order to consolidate the pavement efficiently, maintaining the same weight/length specified in the respective ACI. This compaction process was considered adequate because the initial infiltration rates of the pavement (central region of the sidewalk was 1.28 cm/s to 1.59 cm/s) are similar to the infiltration rate measured in the laboratory tests (1.32 cm/s). Figure 4 shows a schematic cross-section of the pavement.

Figure 4: Schematic cross-section of the sidewalk

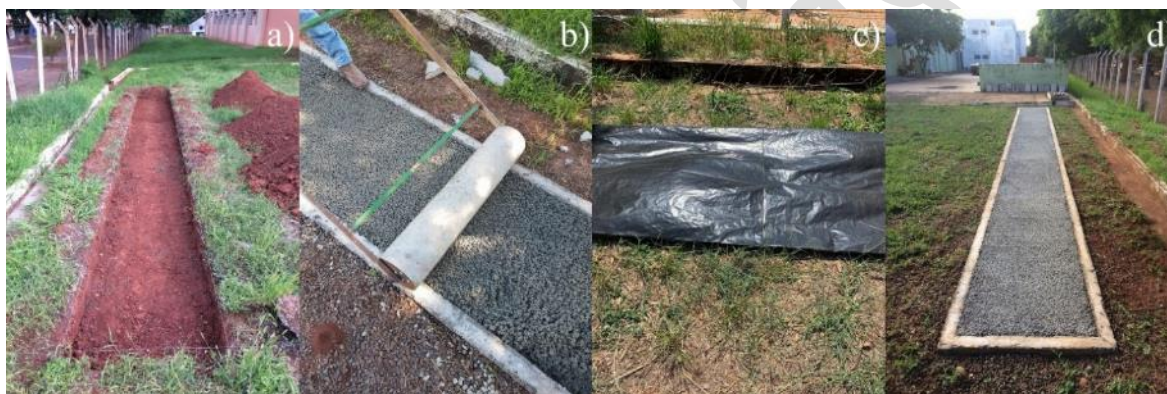
The literature recommends that curing be performed for at least seven days with plastic sheeting immediately after placement and compacting [3]. In this study, curing was carried out over a 14-day period by covering with plastic sheeting; water was sprayed on the pervious concrete surface every day to maintain moisture. Figure 5 shows the stages of pavement construction.

Figure 5: Stages of pavement construction: (a) Excavation; (b) Placement, consolidation and finishing; (c) Curing procedure; (d) Finished pavement

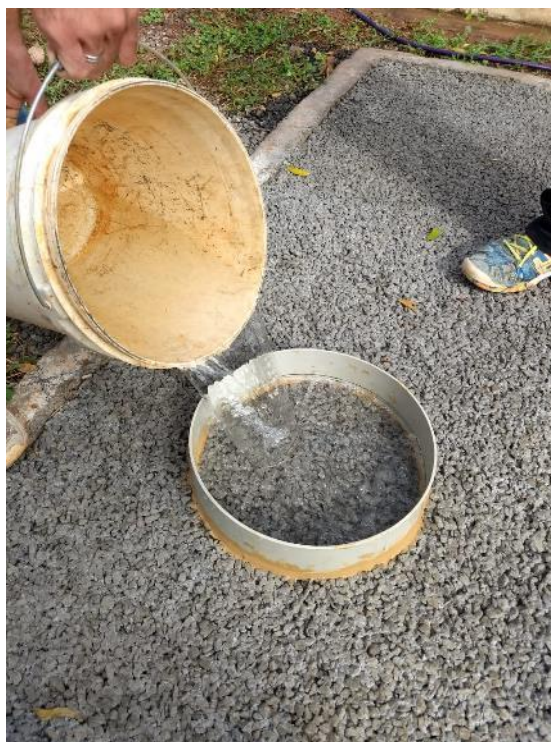
Infiltration rate tests were performed according to ASTM C1701 [43]. For this test, a 30 cm diameter cylindrical ring was placed on the pavement surface and sealed along its bottom edge so that when water was poured into it, it kept a constant head between 1 and 1.5 cm until all the water was poured (Figure 6). The sealing used bentonite clay instead of the plumber's putty specified in the standard due to the superior performance of clay under the high ambient temperatures conditions common in the study region ($> 25^{\circ}\text{C}$). Drake and Bradford [44] used a similar change in sealing material under similar climatic conditions. As advised by ASTM C1701 [43], 18 kg of water were used to perform the test, after a pre-wetting. The result for each spot was the average of two tests conducted in sequence.

Figure 6: ASTM C1701 infiltration rate test

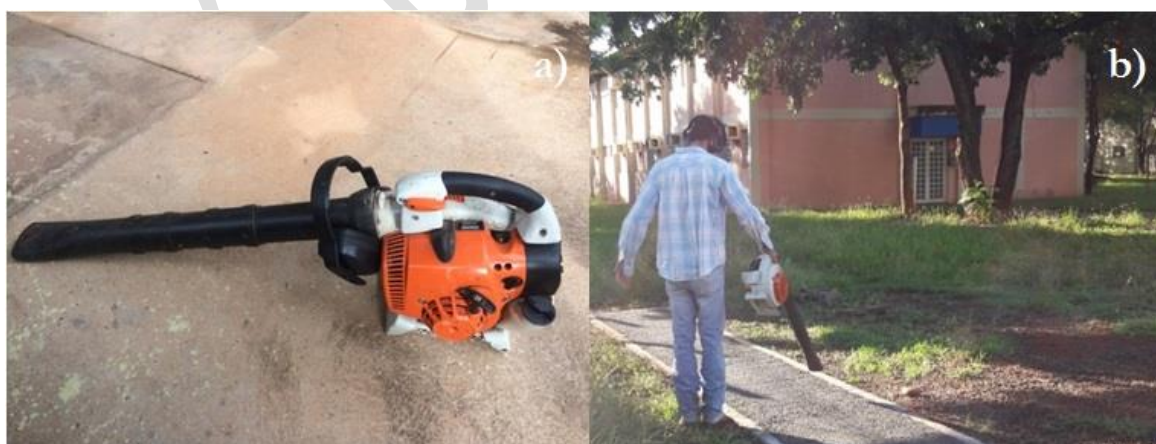
The blower can be used to clean gardens, grounds, agricultural machinery, industrial areas, and large public areas and for stadium and highway maintenance, as indicated by the supplier. Cleaning is carried out by blowing the surfaces. As pervious concrete is normally used in large public areas and private parking lots, the efficiency of periodic cleaning with this equipment was studied in this work (Figure 7). The equipment used in this work was a Still gas blower BG 86, with engine power of 0.8 kW (1.1 hp), maximum air flow rate of 810 m³/h, and air velocity of 85 m/s (with fan nozzle). The blower was performed with the nozzle inclined 45° and 10 cm above the surface. It was blown from the edges to the centre in each half of the pavement.

Figure 7: (a) Blower equipment; (b) Pavement cleaning

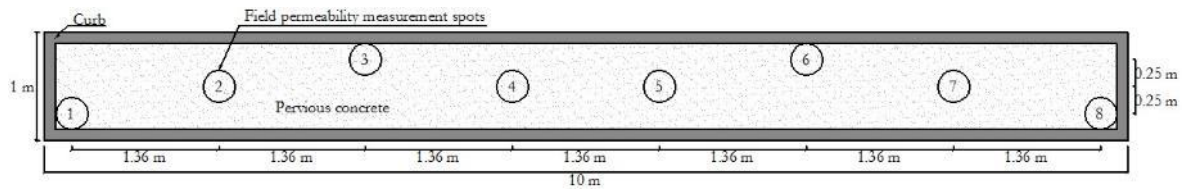
were numbered 5–8. The spots were arranged symmetrically in the two halves, with some spots placed in the corners, near the ends of the curb, while others were placed more to the centre, away from the curbs. These locations were selected to observe any variability due to the distance from the edge and obtain a general average for the pavement, considering the regions of edges and centres. Figure 8 shows the locations of the test spots on the constructed sidewalk.

Figure 8: Top view of the pavement and locations of the infiltration rate test spots

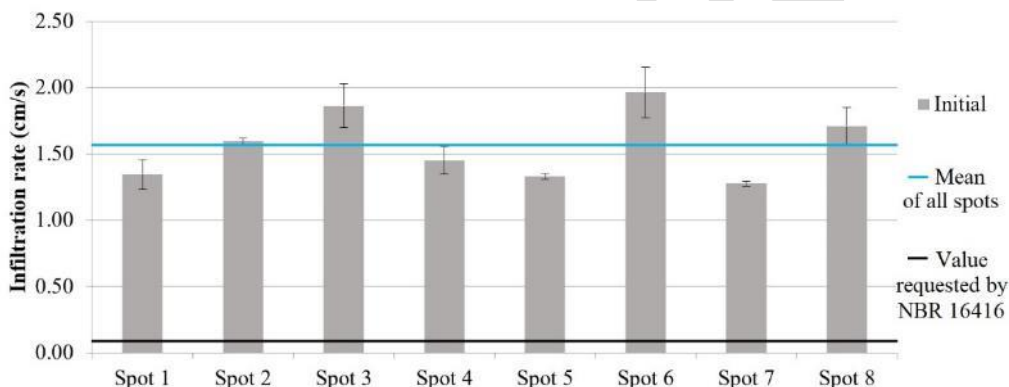
The infiltration rate of the pavement soon after removing the plastic sheeting was divergent among the eight spots (Figure 9). However, similar behaviour was observed in spots measured in the same symmetrical position. For example, the highest infiltration rates were observed at spots 3 and 6, both located symmetrically close to the curb, reaching infiltration rates of 1.86 cm/s and 1.96 cm/s, respectively. On the other hand, spots 2, 4, 5 and 7, all central, had initial infiltration rates that also varied with close values, from 1.28 cm/s to 1.59 cm/s. Only the corner spots, 1 and 8, did not present similarities, exhibiting infiltration rates of 1.35 cm/s and 1.71 cm/s, respectively. The mean value of all eight spots was 1.57 cm/s. These values are in agreement with the values found by Kayhanian *et al.* [9]. All infiltration rates are above the minimum value (0.10 cm/s) requested by NBR 16416 [45].

Figure 9: Initial infiltration rate of the pavement

Except for spot 1, all three other spots close to the curb, 3, 6 and 8, presented initial infiltration rates higher than the centred spots. The probable explanation for this phenomenon is the unequal compaction that can occur in different regions of the pavement. Figure 10 shows that the concrete closer the curbs was more porous and less compact than in the centres. This lower compactness increases the flow rate of water and provides greater percolation, thus making the pavement slightly more permeable near the curbs. Consequently, their strength should fall. From these observations, to get around this situation, it might be useful to use smaller roller so that it is passed more often close to the curb, where more attention is needed.

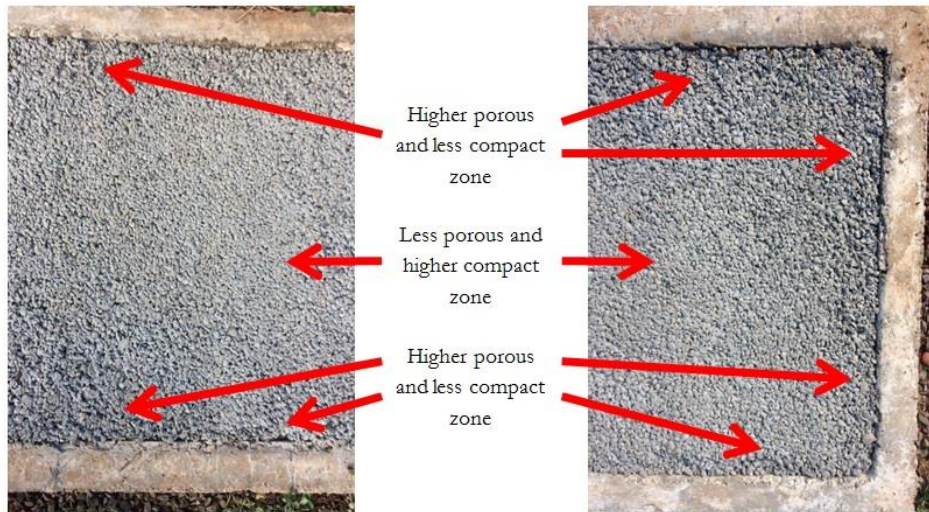
Figure 10: Pavement surface

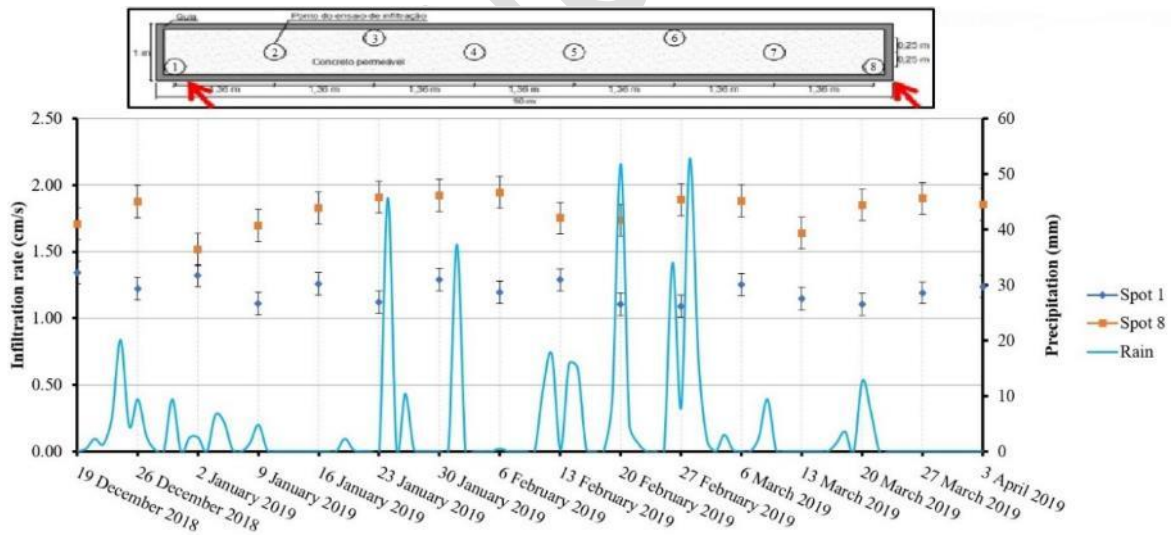
Figure 11: Comparison between the infiltration rates of spots 1 and 8 over time

Spots 1 and 8 were the symmetrical spots with the most distant infiltration rates. The difference between the infiltration rates for the two spots remained approximately constant over time. Table 4 can help to see more clearly the behaviour regarding infiltration rate of spots over time. Monthly cleaned spot 1 showed infiltration rates ranging from 1.09 cm/s to a maximum of 1.35 cm/s, which was the initial infiltration rate, while spot 8, cleaned weekly, had infiltration rates that ranged from 1.52 cm/s to 1.95 cm/s over time. Although the infiltration rates were not very close, through the graphical analysis we do not notice a significant difference during the period analysed for the two spots, considering deviations. During the period of the tests, it rained in almost every week. This is common during the summer in the study region. By graphical observation, the rain does not seem to interfere significantly with the infiltration rates. Heavy or less intense rains, near or far from the days of the tests and with more or less rainfall, do not seem to interfere significantly with these measurements.

To better understand the behaviour between corresponding spots of the weekly and monthly cleaning regions, a comparison of the infiltration rates over time was carried out (Figures 11–14). The daily rainfall events in the region of the study throughout the analysis period were also inserted in the comparison. Rainfall data were obtained through the Climate Channel of UNESP - Ilha Solteira, which provides meteorological variables obtained by automatic weather stations in some cities of the Northwest of São Paulo state [46]. The data used were from the station located in the city of Ilha Solteira, which is just over a kilometre from the site of the sidewalk. It is important to note that infiltration rate measurement was always performed without rainfall. As the tests were always performed in the morning, it did not rain before or during the test; that is, the rains occurred in the afternoon or evening when it rained on test days.

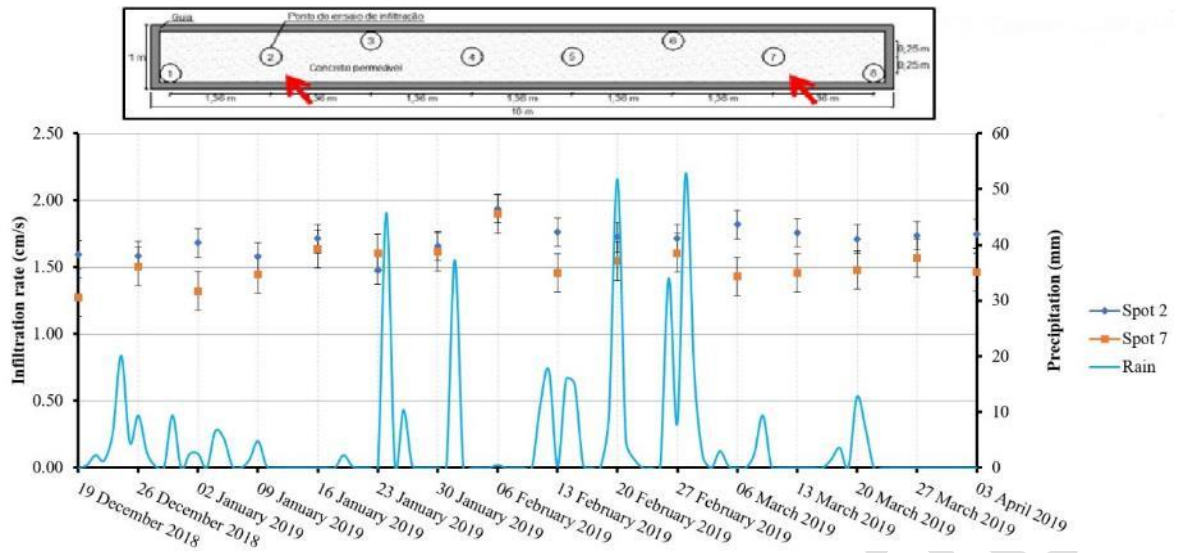
Figure 12: Comparison between the infiltration rates of spots 2 and 7 over time

For the comparison between spots 2 and 7, although the infiltration rate of spot 2, cleaned monthly, was slightly higher, the difference between the infiltration rates is small. The infiltration rates of spots 2 and 7 ranged from 1.48 cm/s to 1.94 cm/s and 1.28 cm/s to 1.90 cm/s, respectively, during the observation time. The graphical observation shows that, over time, the values remain close and do not show a reduction in infiltration rate, considering deviations. Again, the rain does not appear to interfere with the infiltration rate.

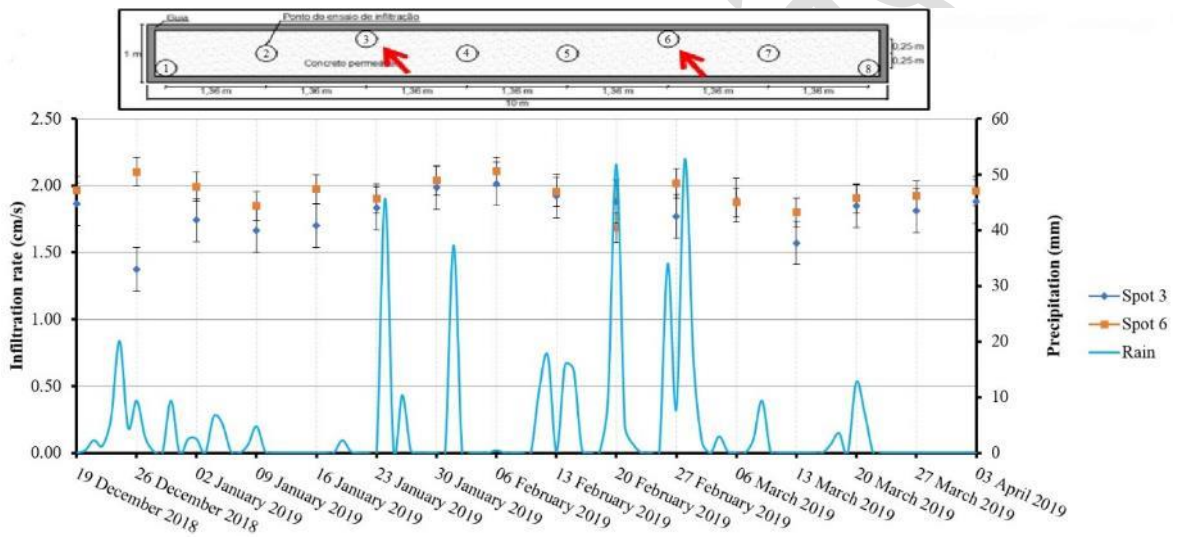
Figure 13: Comparison between the infiltration rates of spots 3 and 6 over time

Comparing spots 3 and 6, the infiltration rates are very close but on average, spot 6, which is cleaned weekly, is slightly higher. The infiltration rates ranged from 1.68 cm/s to 2.11 cm/s for spot 6, and at spot 3 the rates ranged from 1.37 cm/s to 2.01 cm/s. The infiltration rates over time for these two spots remain relatively unaltered and the rain also does not seem to interfere significantly.

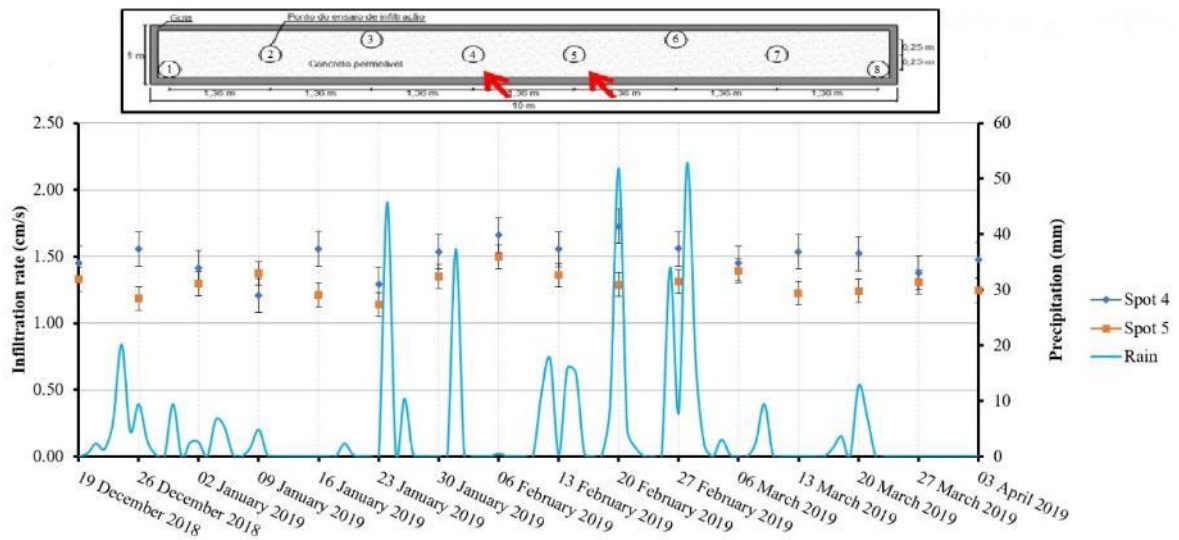
Figure 14: Comparison between the infiltration rates of spots 4 and 5 over time

Finally, the behaviour analysis of spots 4 and 5 also showed close infiltration rate values over time. It ranged from 1.21 cm/s to 1.73 cm/s and 1.14 cm/s to 1.50 cm/s, respectively. As in the other spots, these also presented a constant behaviour without decreases. Rain does not appear to influence either, as noted elsewhere.

As is noticeable graphically, there are no apparently significant reductions of infiltration rates for any of the spots compared. However, there are slight variations at all spots at each weekly test. If one considers the standard deviation of the sample data of each spot during the whole period, the largest deviation is found in spot 3, 0.16 cm/s with a 9.00% coefficient of variation. Variabilities in the data can also be found in other works that used the same infiltration rate test method. Li *et al.* [47] compared the ASTM C1701 infiltration rate measurement method with the National Centre for Asphalt Technology (NCAT) method and observed a maximum deviation of 0.11 cm/s for the ASTM method, but its coefficients of variation were higher, around 30%, due to the low permeability rates of the pavements they studied, variations of 0.02 cm/s to 0.82 cm/s were observed in Asphalt Concrete-Open Graded and Interlocking Concrete Paver-Permeable, respectively. As the infiltration rates of the present study are higher, this deviation can be considered acceptable. Apparently the monthly or weekly cleaning periodicity has similar efficiency, as it did not seem to cause significant differences in the infiltration rate of the pervious pavement during the period considered.

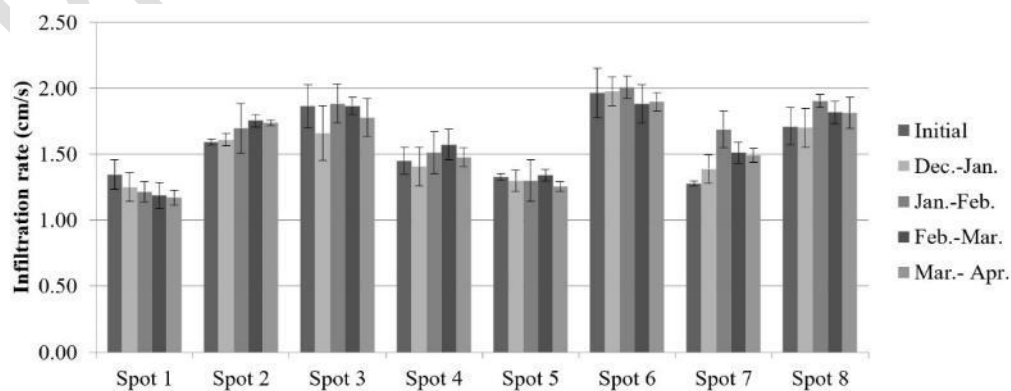
Figure 15: Monthly means of each spot throughout the period of data collection

The analysis of the monthly means at all spots makes the tendencies of the infiltration rates more evident. Spot 1 is the only one that has an apparent slight reduction of infiltration rate over time, month to month, while spot 2 was the only one that presented a gradual and slight increase in infiltration rate over first three months, stabilizing in the fourth. Both were cleaned monthly. The other spots do not apparently follow a monthly trend, varying over months and, from the standard deviations, spots 7 and 8 presented a slight increase in the infiltration rate in relation to the initial rate. Spots 3, 4, 5 and 6 maintained constant permeabilities when compared to the initial one. Spot 3 presented the highest standard deviation in the monthly means between the same spots in the period from December to January, with 0.21 cm/s and a 12.53% coefficient of variation. This was the period of greatest variability for spot 3, but it is not too far from the maximum deviation observed for the entire four-month period of data collection, as seen in Section 3.3.

A mean monthly analysis was also performed every four weeks, as seen in Figure 15.

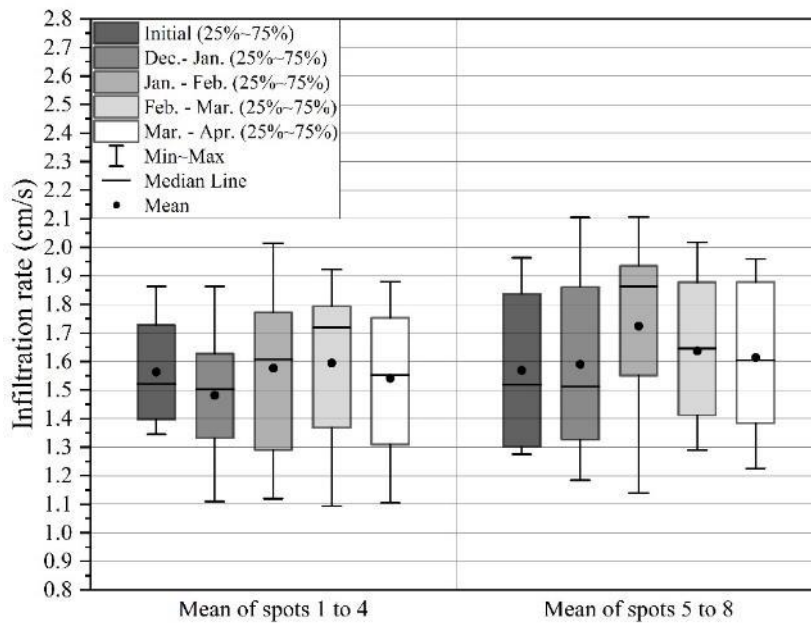
Figure 16: Monthly means of the four spots of each half, cleaned monthly and weekly

The graphical analysis (Figure 16) shows that the half of the pavement cleaned monthly, spots 1–4, and the half cleaned weekly, spots 5–8, do not show significant differences in the infiltration rates, considering the deviation standards. In this case, the deviations were slightly higher because they encompassed the average of the four spots for each half of the pavement and, as the infiltration rate between different spots had greater variation, the maximum deviation seen in this comparison was 0.32 cm/s with 20.77% coefficient of variation. For both halves, the means values over the months also remained practically constant.

Figure 16 shows a monthly mean analysis of the four spots on each half of the pavement.
