Assess of hollow clay block masonry wallets under high temperature

Rogério Cattelan Antochaves de Lima¹, Alessandro Onofre Rigão¹,
Gihad Mohamad¹, Larissa Deglioumini Kirchhof¹,
Almir Barros da Silva Santos Neto¹

¹ Universidade Federal de Santa Maria - UFSM, Avenida Roraima, Centro de Tecnologia, Santa Maria, Rio Grande do Sul, Brasil.

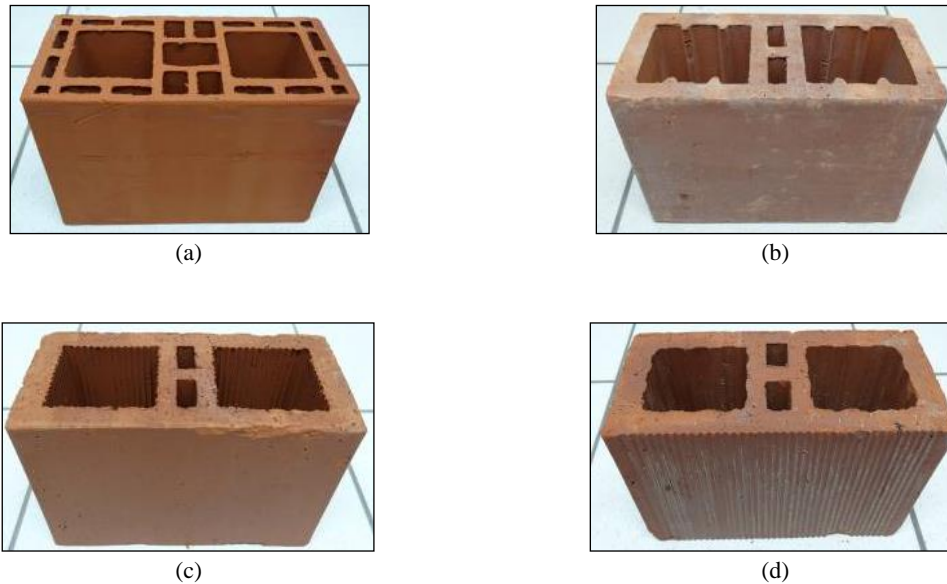
Figure 1 presents the clay structural unities named A, B, C, and D. Block A presents longitudinal and transversal hollow walls and a double central hollow septum, with smooth internal and external surfaces; type B block presents solid longitudinal and transversal walls, with a double central hollow septum having an equivalent thickness to the other block walls; block C has the same geometrical characteristics as block B, except for the grooves on the internal surfaces and cavities; at last, block D present the same geometry as block B and C, however, in this case, the external faces are grooved.

Figure 1: Visual aspects of the four clay blocks used to build the masonry wallets.

Comparing the components, it was observed that the wallet A performed best for thermal insulation, due to the longitudinal and transversal walls being hollow, reducing thermal transmission as more air is trapped inside. The components built with block types B, C and D, had similar geometries, however, with different class of resistance. Observing the behaviors during the test, it is suggested that a higher resistance level for blocks and mortar could aid in increasing the time of thermal insulation.

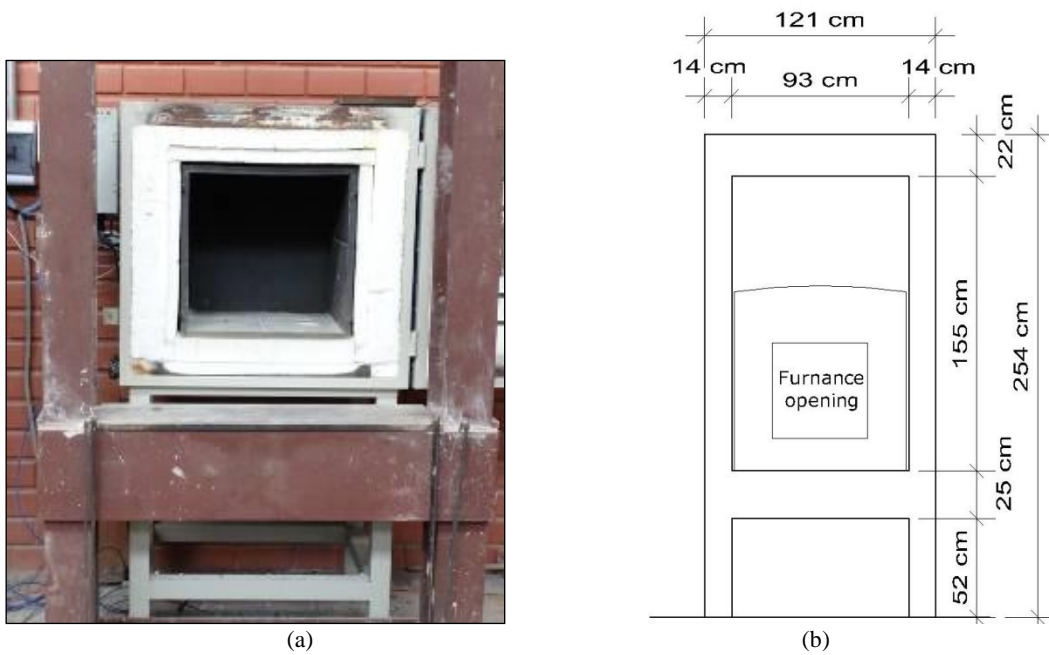
In order to apply fire conditions to one of the surfaces of the structural panels, it was used a three-phase modular electric furnace of 18 kW/h of power, with a digital automatic temperature controller micro-processed and precision of 1°C. The equipment has a Kanthal A steel resistance and thermal insulation in ceramic fibers. The power allows temperatures to reach 1050°C. The internal useful dimensions measured 50 cm wide, 50 cm high and 50 cm deep. Figure 2 (a) shows a frontal view of the furnace aperture with its internal useful dimensions. Around the furnace, for a better fitting and support of the structural masonry panel, it was coupled a reaction portico built with steel plates, presenting dimensions and geometry as reported in Figure 2 (b).

Figure 2: (a) General aspect of the furnace; (b) furnace opening for service load application.

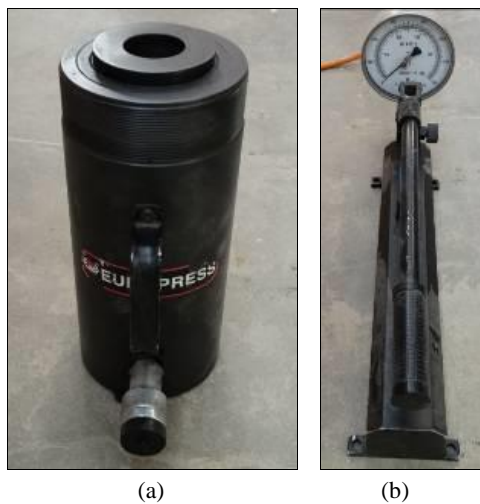
The service load was applied by the means of a hydraulic jack with maximum 500 kN of loading capacity, engaged by a manual pump with a pressure limit of 10,000 psi (68.9 MPa) and analogical display for load readings, as per Figure 3. The hydraulic jack was placed on the top portico beam and fixed by a metallic trail.

Figure 3: (a) Hydraulic jack and (b) manual pump for service load application.

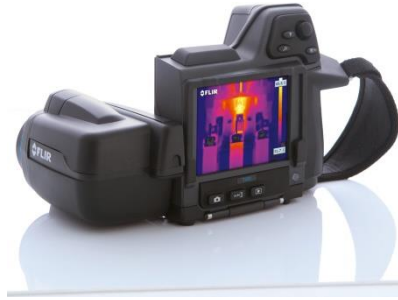
The thermal measurements on the external panel surface, not directly exposed to the heat, was realized through a thermographic camera with an infra-red sensor; the camera thermal sensibility spans from 0.045°C to 30°C, being able to determine temperatures between -20°C and +1200°C and to visualize hot points at distances from 14 mm to 10 meters (m) with 76,000-pixel resolution. In Figure 4 is possible to visualize the equipment employed during the experiments.

Figure 4: Thermographic camera with infra-red sensor (Source: <http://www.contemp.com.br/produto/flir-t440/>).

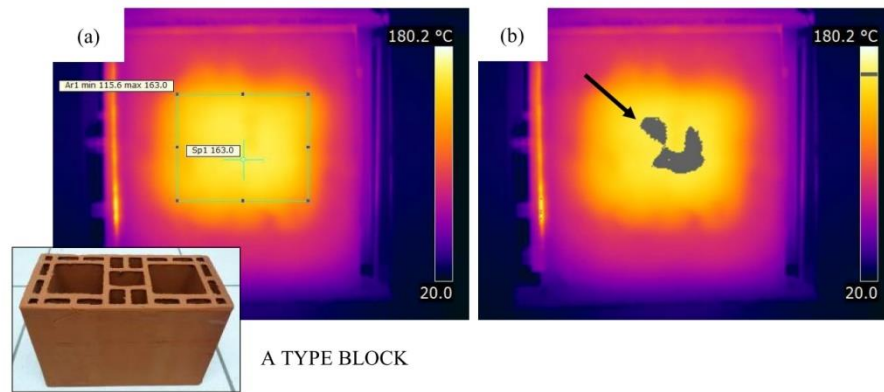
With the aid of the thermographic camera for the temperature readings after exposition to 900°C for 4 hours, it was verified that for the masonry component built with block type A, the maximum temperature recorded for the unexposed surface was 163°C. This value is lower than the limiting condition set for 180°C, plus room temperature, at any point. Moreover, the average temperature presented by the unexposed surface was 150.2°C, also lower than the limiting criteria of 160°C (140°C + room temperature). Figure 5 presents the maximum temperature recorded by thermal image (a) and the isothermal curves for the temperatures between 160 e 163 °C (b).

Figure 5: Block A wallet after 4h of exposition to 900°C: (a) thermal image; (b) the isothermal region of temperatures between 160°C and 163°C is presented in grey.

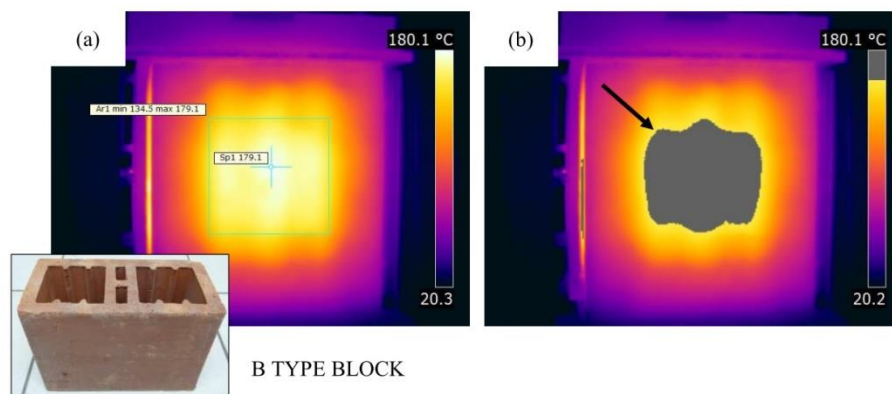
Regarding the component built with B block type, after 2 h and 30 minutes of exposition to 900°C, it was verified that the maximum temperature reached was 162.3°C (below the limiting condition of 180°C + room temperature) and that the average temperature recorded was 150.6°C, also below the limit of 160°C. These values indicated that after 2 h and 30 minute the wallet was still presenting a satisfactory thermal insulation. However, the temperature readings after 3hours of testing, revealed that one of the limiting condition for thermal insulation were exceeded: the external temperature reached 179.1°C, while the average temperature raised to 165.5°C (above 160°C), suggesting that the limiting criteria were overcome in 3 hours' time. Figure 6 shows the maximum temperature obtained by thermal imaging (a) and the isothermal curves for the temperature range between 160 and 179.1°C (b).

Figure 6: Block B wallet after 3h of exposition to 900°C: (a) thermal image; (b) the isothermal region of temperatures between 160°C and 179.1°C is presented in grey.

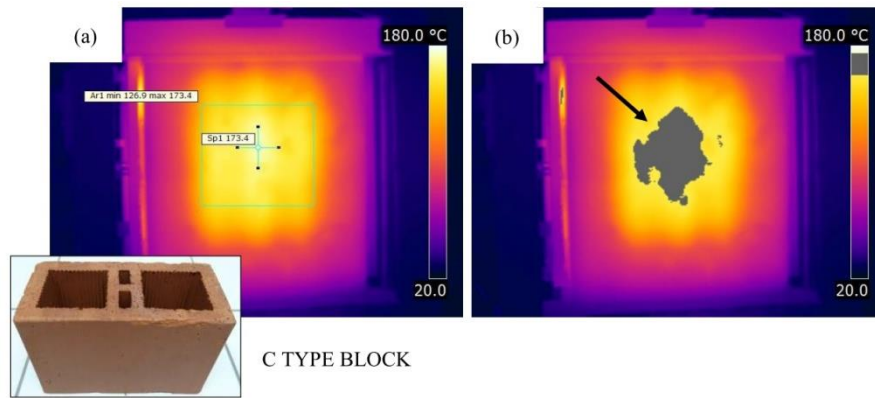
Regarding the tests for the component erected with the C block type, after 3 h and 30 min at 900°C, it was observed that the maximum temperature presented on the external surface reached 173.4°C, while the average temperature was 157.3°C. Both these readings are lower than the established limits (180°C + room temperature for maximum value and 160°C for the average temperature). Figure 7 presents the maximum temperature obtained by thermal imaging (a) and the isothermal curves for the temperature range between 160 and 173.4 °C (b).

Figure 7: Block C wallet after 3h30min of exposition to 900°C: (a) thermal image; (b) the isothermal range of temperatures between 160°C and 173.4°C is presented in grey.

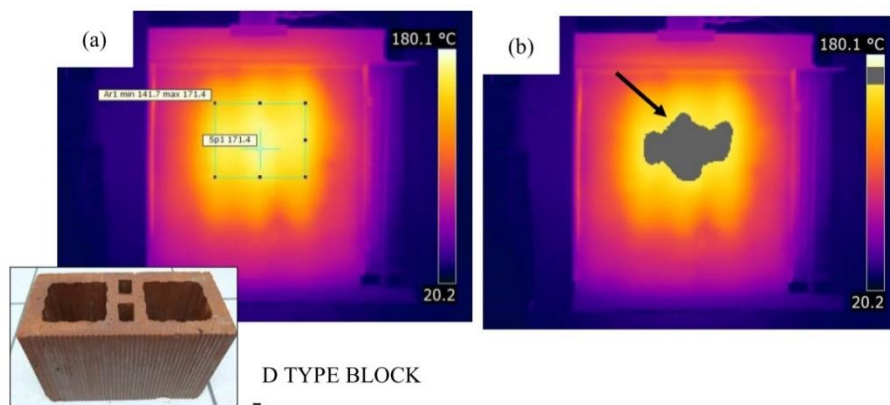
The maximum temperatures on the external surface of the component made by D blocks, after 4 hours, reached 171.4°C, while the average temperature was 159.9°C. Once again, it was observed that both readings are below the established limit for thermal insulation. Figure 8 shows the maximum temperature obtained by thermal imaging (a) and the isothermal curves for the temperature range between 160 and 171.4 °C (b).

Figure 8: Block D wallet after 4h of exposition to 900°C: (a) thermal image; (b) the isothermal range of temperatures between 160°C and 171.4°C is presented in grey.

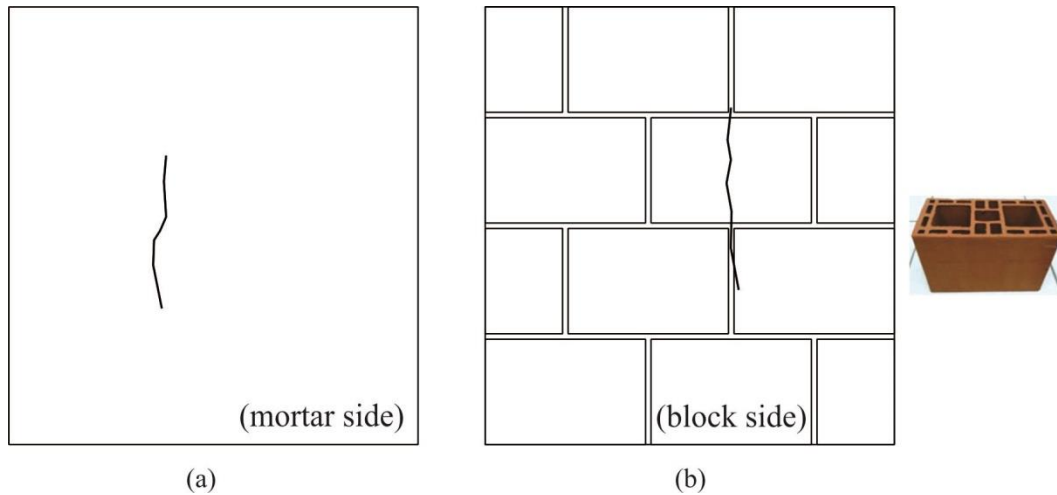
Regarding the panel with A block type, it is possible to observe in Figure 9 (a) that a vertical crack appeared in the grout of the external surface, propagating top-down in the panel, probably due to the thermal dilatation caused by heat. On the internal surface (directly exposed to heat), the mortar coating detached, exposing the same symmetrical vertical crack found on the external surface, which had propagated through the block and the laying mortar, as shown in Figure 9 (b).

Figure 9: External and internal cracking in the wallet built with A block type.

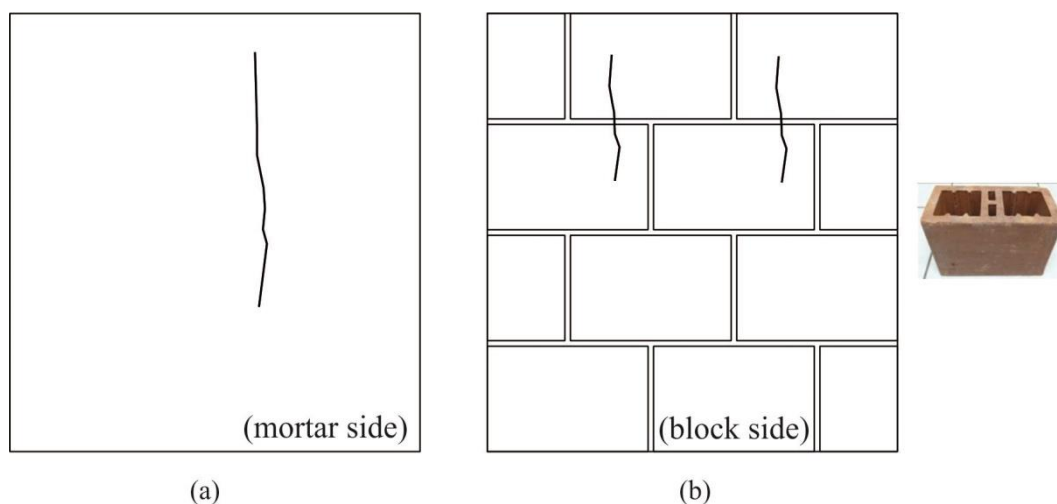
For the masonry structural component built with B block type, vertical cracks rose on the external surface coating; the cracks propagated from top to bottom, probably due to the thermal dilatation caused by heating, as depicted in Figure 10 (a) for the external surface and Figure 10 (b) for the internal surface in contact with the high temperatures.

Figure 10: External and internal cracking in the wallet built with B block type.

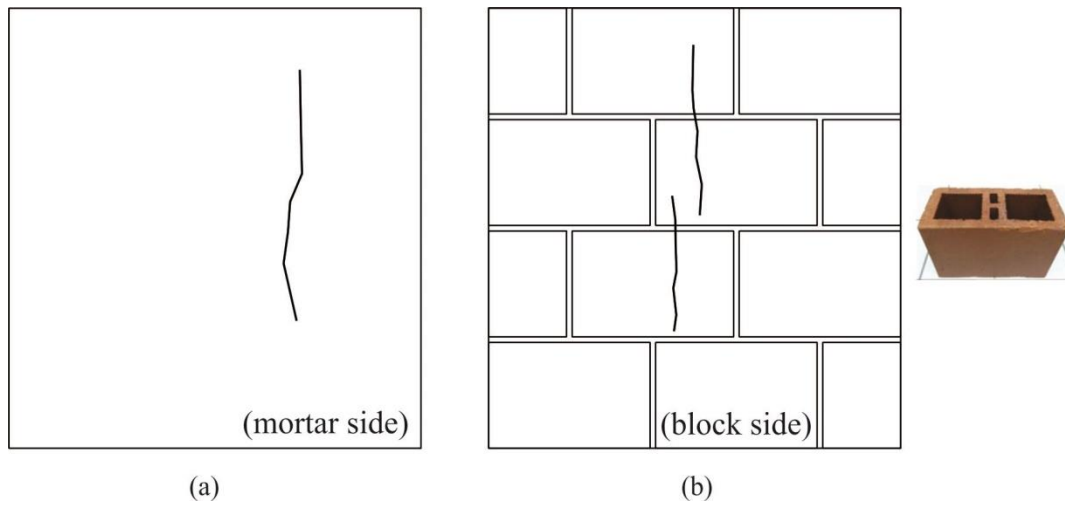
Regarding the component built with the C block type, again, it was observed that the cracks were verticals and propagated in the wallet top-down, as presented in Figure 11 (a). Moreover, as in Figure 11 (b), it was verified the presence of cracking and complete plastering detachment from the internal surface.

Figure 11: External and internal cracking in the wallet built with C block type.

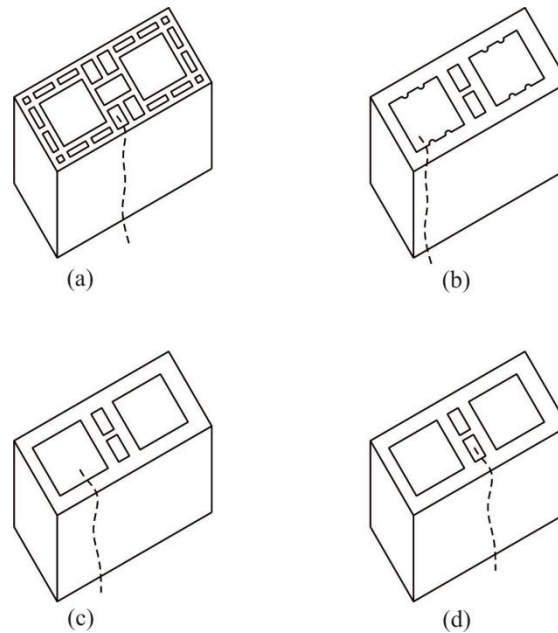
In Figure 13 are represented the crack positions in all the blocks during the high temperature tests. For the block in Figure 13 (a), it was observed that cracking occurred at the double central septum cavity, while for block in Figure 13 (b) and (c) it was localized along the longitudinal face. In Figure 13 (d), the crack was found, again, along the double central cavity.

Figure 13: Position cracking in the different block types.
