Tensile properties and color and mass variations of GFRP composites under alkaline and ultraviolet exposures

ABSTRACT

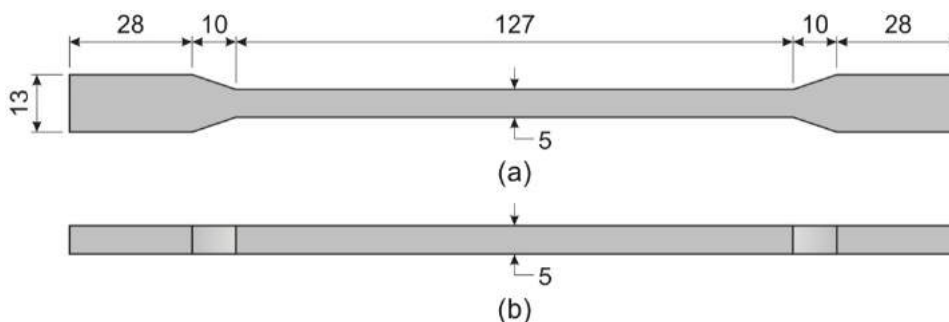
Figure 1: Dimension of the specimens used in the tensile properties tests (values in mm). Top (a) and lateral (b) views.

The GFRP pultruded profiles used in this study were fabricated using a standard pultrusion process in a composite company in São Paulo, Brazil. In the pultrusion process, fibers were impregnated with a low viscous liquid polymer in a resin bath and then the pre-impregnated composites were pulled and cured through a heated die [13]. The profiles were made with matrices of vinylester and phenolic resins reinforced with E-glass fiber (fiber content of 50 and 60 wt.%, respectively) in the longitudinal direction. The E-glass fiber had a diameter of 20 µm, density of 2570 kg.m⁻³, tensile strength of 1.2 GPa, and modulus of elasticity of 70 GPa. The vinylester resin was made with 1.7 wt.% of methyl ethyl ketone peroxide, 0.5 wt.% cobalt chloride as catalyst and accelerator, respectively. The phenolic resin was cured in an oven at 210 °C for 15 min. Specimens for the different tests were accurately extracted from the pultruded profiles using a Discovery 560 Romi vertical machining center. Figure 1 shows the dimensions of the specimens that were based on the studies performed by Vieira [14].

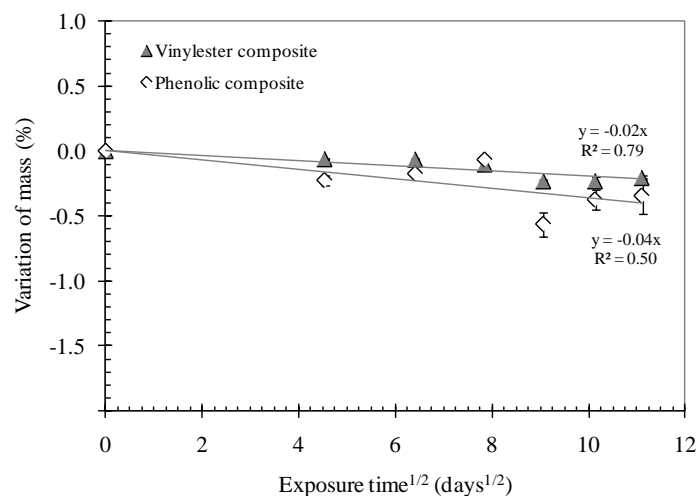
The mass variation of the vinylester and phenolic composites during cycles of UV/water spray is presented in Figure 2. There was no expressive mass variation irrespective of the composite type. As can be seen, 0.2 and 0.3% loss of mass values were observed to vinylester and phenolic composites, respectively, after 480 UV/water spray cycles, indicating only a surface phenomenon. This behavior was confirmed by SEM analysis as discussed in section 3.4. In this case, the loss of mass is likely to be due to the volatiles and residual moisture in the specimens.

Figure 2: Mass variation over time (square root) of the vinylester and phenolic composites exposed to the UV/water spray cycles.

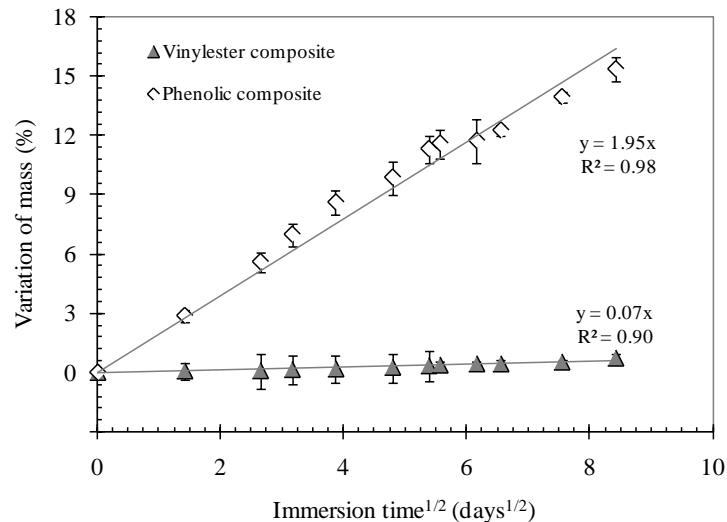
The mass variation was more pronounced in the alkaline exposure than those in UV/spray cycles, mainly for the phenolic composites. Figure 3 shows that the vinylester specimens presented a 0.7% gain of mass after 71 days of continuous alkaline immersion. The gain of mass for the phenolic composite was about 15% in the same immersion period. In both composite types, the gain of mass over the square root of time increased with a constant rate (linear curves with R^2 higher than 90%). This behavior roughly follows a Fickian diffusion behavior, as it was observed by KIM *et al.* [6]. Severity of alkaline exposure on the loss of mass for polyester GFRP was also reported by CORREIA *et al.* [4]. Results of gain in mass for vinylester GFRP were also previously observed [4,6]. However, the gain of mass determined in this study for phenolic composites was much higher than verified by other works. This behavior can be explained to a progressive visible delamination observed in all phenolic GFRP specimens during the alkaline immersion period. In this case, the longitudinal delamination of the phenolic composite can be attributed to a progressive swelling (Figure 4).

Figure 3: Mass variation over time (square root) of the vinylester and phenolic composites exposed to the alkaline solution.

of immersion. However, both alkaline-exposed composites presented significant lower modulus of elasticity values (70%) than the phenolic reference. The loss of tensile strength in the phenolic composites exposed to the alkaline solution was linked with the high mass variation (Figure 3), fiber degradation, and delamination (Figure 4).

exposure has been previously reported by others authors [10-12,10]. After 120 days in alkaline immersion, both vinylester and phenolic composites presented evidence of resin erosion, which induced the appearance of microcracks (Figures 7e and 7f, respectively). This behavior was more pronounced on the phenolic composites, where delaminations along the side of the specimens (longitudinal) were visually observed. This was consistent with the results of mass variation shown in Figure 3.

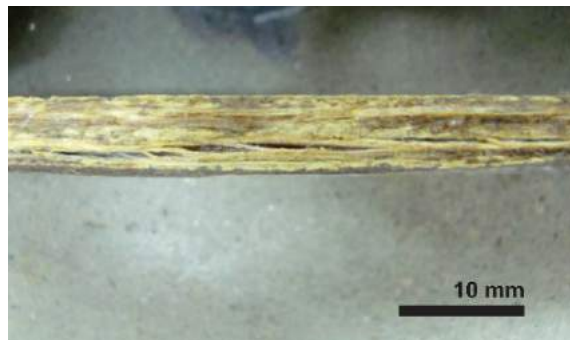
Figure 4: Lateral view of a phenolic composite specimen after 71 days of alkaline exposition.

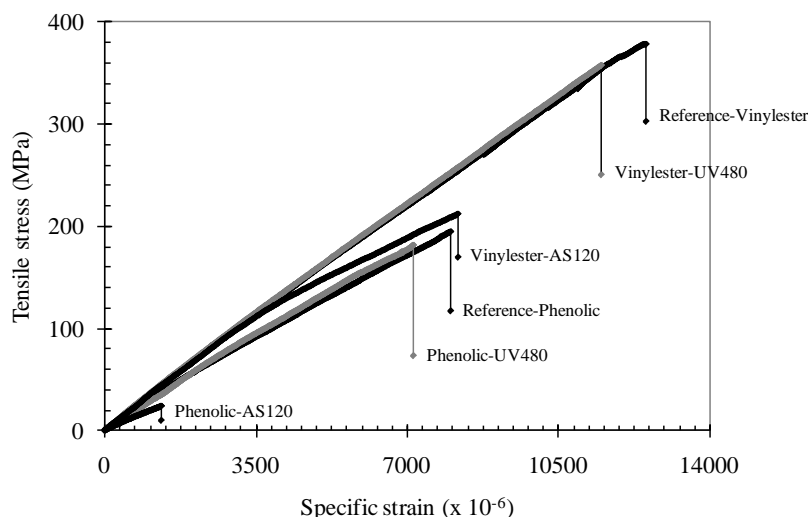
Figure 5 shows the stress versus strain curves for unexposed (reference) and all ultimate exposed composites, where expressive differences in strength and modulus of elasticity were observed due to the studied degradation environments. Both UV/water spray and alkaline exposures reduced the tensile strength of the composites. Based on the obtained values of tensile strength (Table 1), it can be observed that both types of composites presented different strength in relation to the references after 480 UV/water spray cycles. In this case, a reduction in strength of about 10% was observed for both types of composites. A similar reduction was observed in GFRP with isophthalic matrix after about 80 days of UV exposure [4].

Figure 5: Typical stress *versus* strain curves of the vinylester and phenolic GFRP specimens.

The differences in the stress-strain curves of the reference and the alkaline specimens (Figure 5) clearly showed the aggressive action of the alkaline environment on the tensile properties. In fact, the reduction in tensile strength of both composites was more pronounced in the alkaline solution immersion than those in the UV/water spray exposure. After 120 days of immersion, significant reductions of about 40 and 90% in strengths were observed for the vinylester and phenolic composites, respectively, in relation to the references. Reductions of about 20 and 80% were observed for the vinylester and phenolic composites, respectively, after 90 days. In spite of the alkaline-vinylester composites presenting similar modulus of elasticity values in relation to the reference, the final slope of the curves decreased while strain increased. For phenolic composites, no significant differences were observed between the modulus of elasticity values after 90 and 120 days

The clean surface of a fiber from the vinylester composite exposed to the alkaline solution, shown in Figure 8a, confirmed that the microcracking indicated in Figure 7e was a surface phenomenon. This corroborated with the mechanical behavior of the vinylester composite (Figure 5 and Table 1). It was confirmed that the vinylester resin could inhibit the penetration of alkalis into GFRP composites immersed in alkali solutions [21]. On the other hand, the continuous exposure to the alkaline solution affected the fiber surface of the phenolic composite. In this case, with the delamination, there was a direct contact between the glass fibers and the alkaline solution. Thus, clusters of hydrated compounds were observed around the fibers, as shown in Figure 8b. This helped to understand the expressive reduction in tensile strength observed with the alkaline-exposed phenolic composite in comparison with the reference composite. Moreover, it seems evident that the damage mechanisms of phenolic composite exposed to the alkaline solution were mainly interfacial (fiber-matrix bond) and fiber related mechanisms.

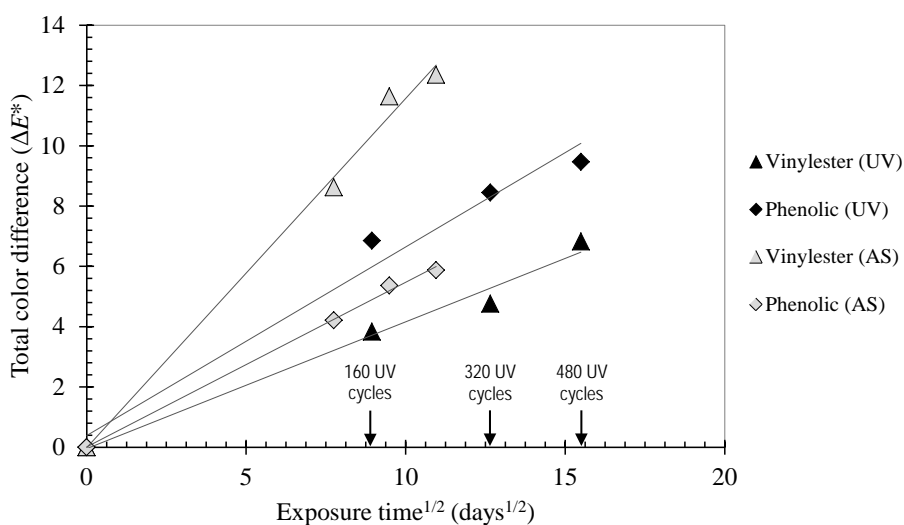
The total color difference (ΔE^*) values for all exposed composites increased with the exposure time, as can be seen in Figure 6. Based on statistical analysis (ANOVA), the ΔE^* was significantly influenced by the number of cycles and immersion time for UV/water spray and alkaline exposure, respectively. A good linear correlation between the ΔE^* and the square root of time was found for all curves ($R^2 > 0.97$). The vinylester composites had the ΔE^* values between 3.8 (after 160 cycles) and 6.8 (after 480 cycles) and the ΔE^* values of the phenolic composites ranged between 6.8 and 9.5 after 160 and 480 UV/water spray cycles, respectively. Considering the measurements performed immediately after 60 days of alkaline immersion for both composite types, the ΔE^* values were 8.6 and 4.2 for vinylester and phenolic composites, respectively.

Figure 6: Total color difference (ΔE^*) values of vinylester and phenolic GFRP specimens exposed to the UV/water spray cycles (UV) and alkaline solution (AS).

It is important to note that the visual observations of the discoloration of the specimens were very informative. In fact, the specimens of both phenolic and vinylester composites presented detectable color changes after all observed times indicated in Figure 6. This occurred because the ΔE^* values were higher than the difference values ($\Delta E^* = 3.3$) recognizable by all people [19], i.e., the color changes after the exposure was easily distinguished by the human eye. The photodegradation of the vinylester composite was manifested by yellowing of the composite (increase of b^* value in the CIE 1976 $L^*a^*b^*$ color system), while the UV/water spray exposure darkened the color of the phenolic specimens (decrease of L^* and increase in a^* and b^* parameters). The results showed that the continuous exposure in the alkaline solution also darkened the color of the phenolic specimens. On the contrary, the vinylester composites exposed to the alkaline solution lightened, with increases in L^* value.

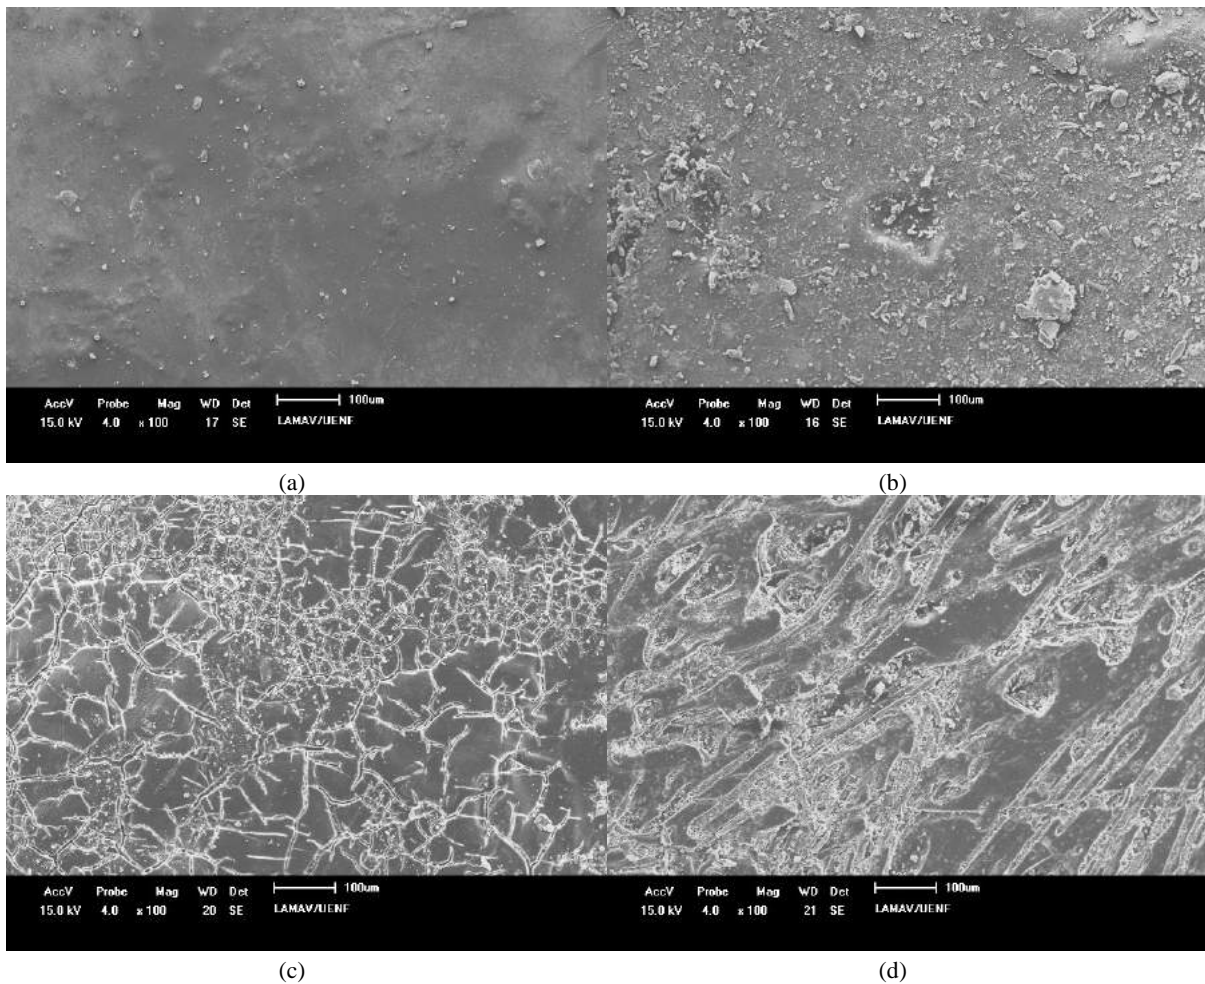
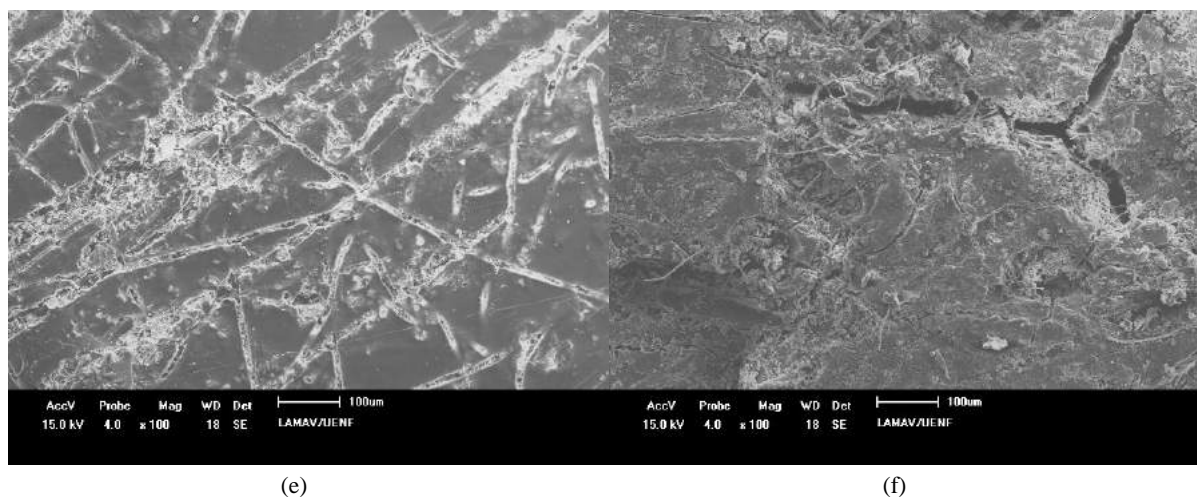
SEM micrographs of the surface morphologies of different specimens before and after both UV/water spray and alkaline exposures are shown in Figure 7. Both vinylester and phenolic unexposed composites were initially smooths (Figures 7a and 7b, respectively). The surface of vinylester and phenolic composites was expressively degraded after 480 cycles of the UV/water spray, as indicated in Figures 7c and 7d, respectively. In fact, microcracks appeared on each composite indicating, as expected, that the photodegradation of polymeric composites caused apparent surface microcracking. A similar microcracking phenomenon under UV

Figure 7: SEM micrographs of composites: (a) unexposed vinyl ester composite; (b) unexposed phenolic composite; (c) vinyl ester composite exposed to 480 UV/water spray cycles; (d) phenolic composite exposed to 480 UV/water spray cycles; (e) vinyl ester composite exposed to 120 days in alkaline solution; (f) phenolic composite exposed to 120 days in alkaline solution.

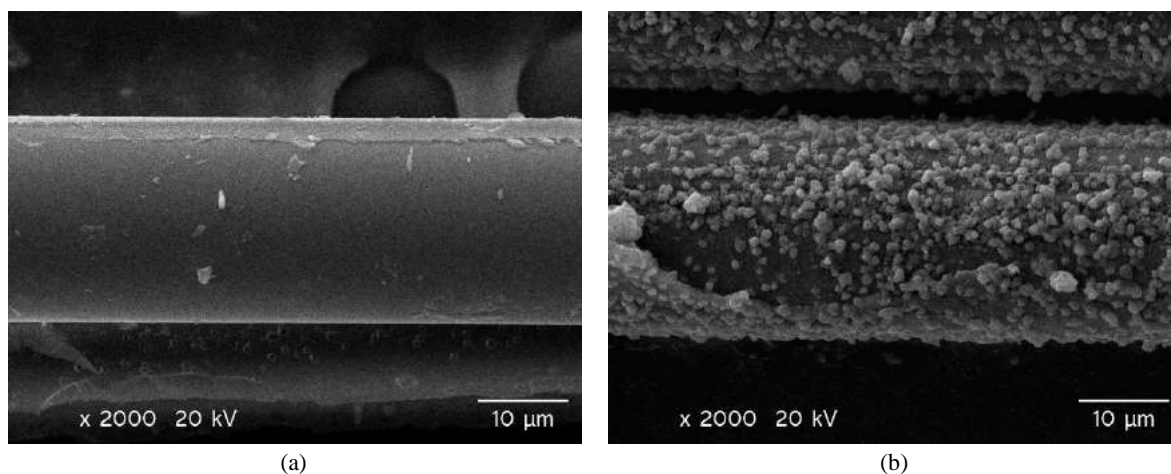
Figure 8: SEM micrographs of glass fiber of the (a) vinyl ester and (b) phenolic composites exposed to 120 days in alkaline solution.
