## Construction of Buildings in Soft Clay Deposits: A Case Study in a Public School in Florianópolis/SC, Brazil

In the present study, it is considered as a case study the structural condition of a public school (Anísio Teixeira Municipal School – ATMS) in the West Side region of the Costeira do Pirajubaé Massif, in Florianópolis/SC. The school is situated on a steep and densely urbanized slope. In 2019, beams and column breakages were found in classrooms and bathrooms at the school, which showed risk in its structure. From these data, it became relevant to develop a structural analysis of the school, through geological, geotechnical, and geophysical assessments.

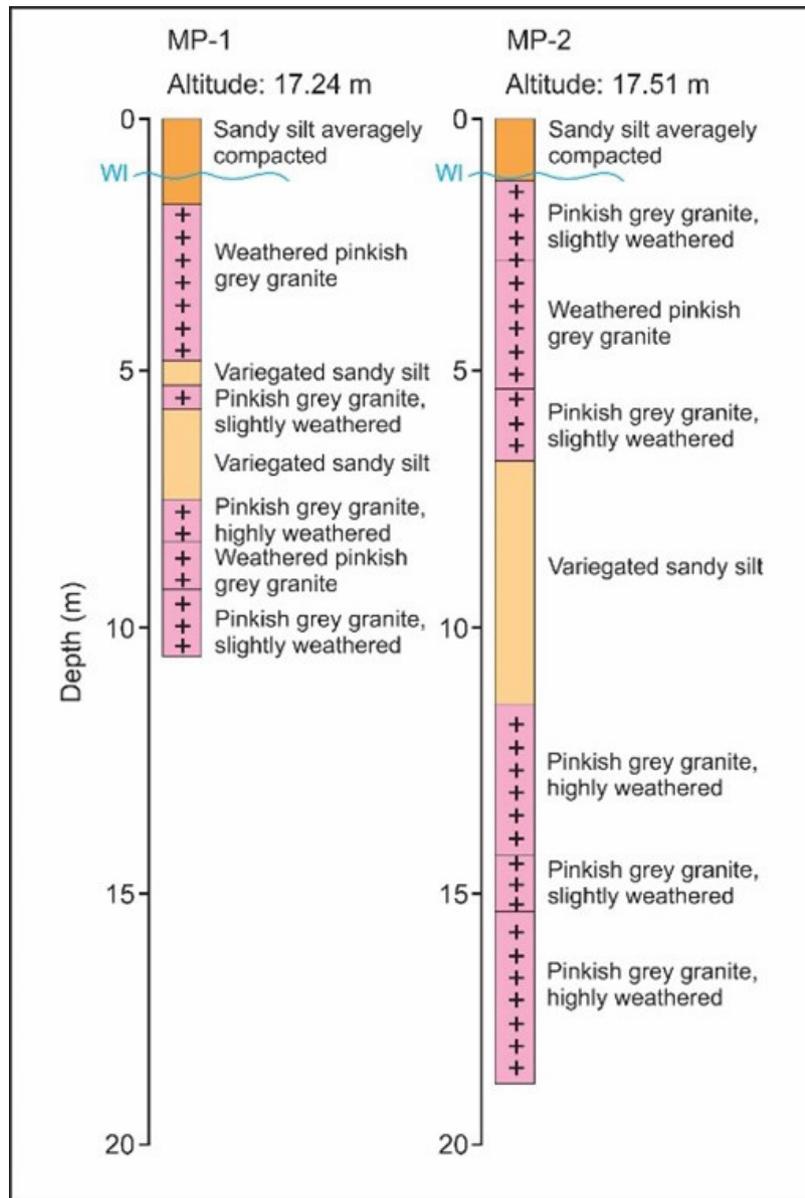
It was evaluated 2 Mixed Probings (MP), developed downstream of the classroom that presented the cracks (Figure 1), at 17 m, on the occasion of the Sports Gym project. This area had great relevance for understanding the geology of the study area (Figure 1). In the Mixed Probings analyzed MP-1 and MP-2, it is identified landfill material up to 1.15 m, followed by a pinkish-gray granite (ranging from very altered to little altered). The MP-1 was finished at a depth of 11.51 m, and the MP-2, at 18.29 m. In both soundings, the water level was 1m deep, as shown in Figure 11.

Figure 11 Mixed probings carried out at 17 m, downstream of the classroom that showed cracks, corresponding to MP-1 and MP-2, respectively.

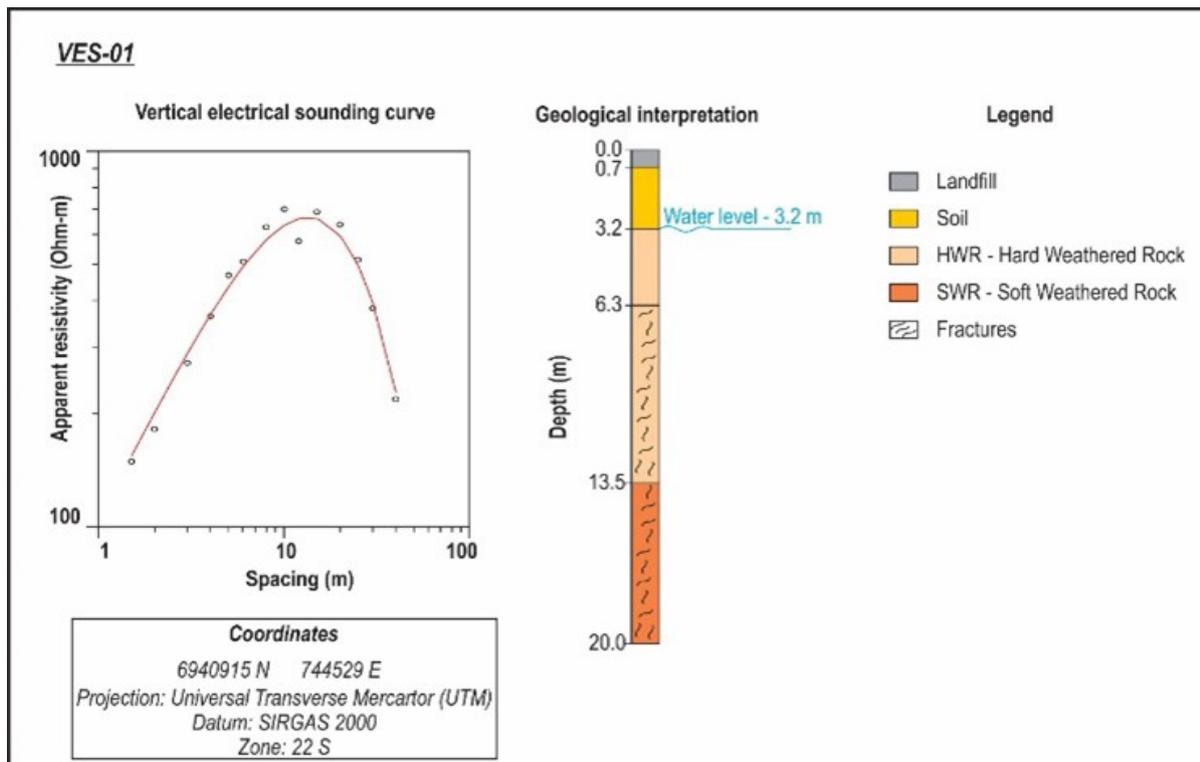
It was performed the VES-1, which is important, mainly, for defining the water level, as well as the soil type and rock alterability along the profile, upstream of the classroom that presented cracks (Figure 1). Through the geophysical survey, it is identified landfill up to 0.7 m, followed by soil up to 3.2 m (Figure 12). From this depth up to 13.5 m, it is observed a hard weathered rock, followed up to 20 m by soft weathered rock. It was determined the water level at the contact between the soil layer and hard altered rock, at a depth of 3.2 m.

Figure 12 Vertical Electrical Survey (VES) (TECGEO 2019).

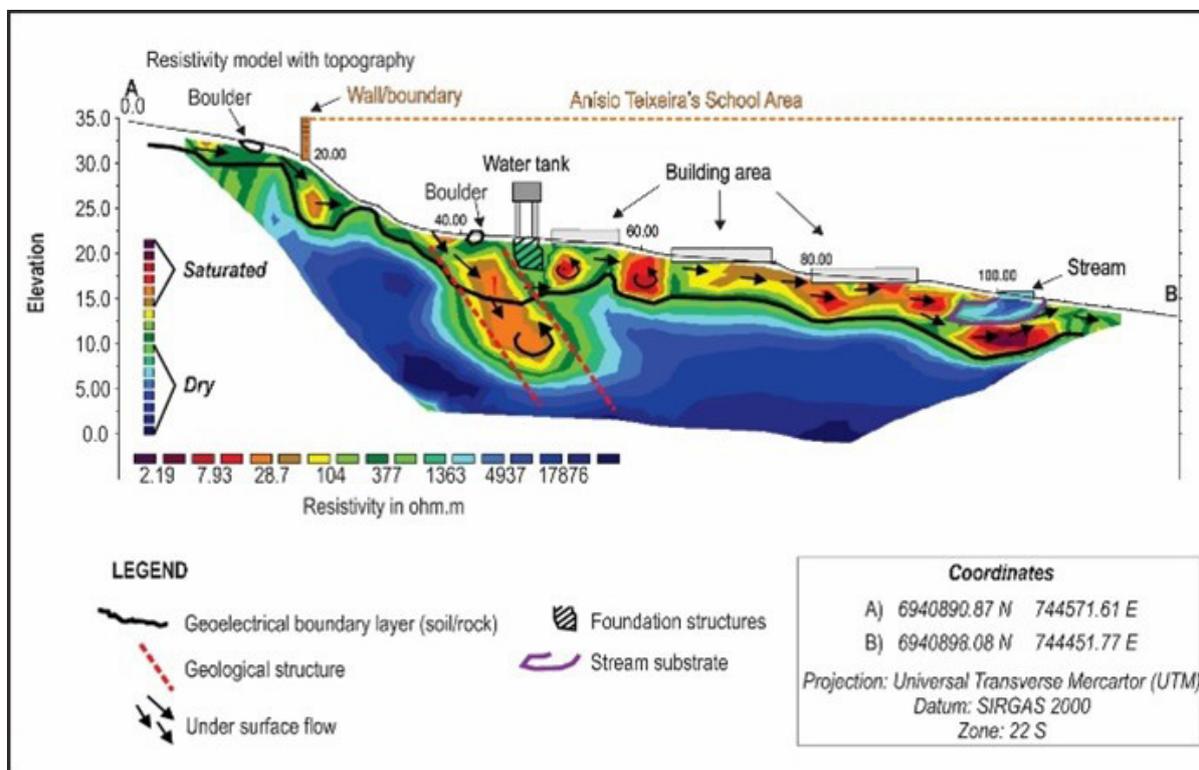
The electric surveys ER-1 (Figure 13), ER-2 (Figure 14), and ER-3 (Figure 15) were important in the determination of the geometry of the layers, the strength of materials, and geological structures. The underground flow is arranged in soil-rock contact. Low resistances, between

10 and 20 ohm.m, indicate predominantly clayey soils, which are identified locally, mainly between 20 and 15 m. It is identified slightly higher resistances, between 20 and 40 (ohm.m) clayey sand soils, 40 and 60 (ohm.m) sandy clay soils, and 60 to 300 (ohm.m) sandy soils, more frequently, both downstream and upstream from the classroom that presented the cracks, between 35 and 15 m. It is also identified high resistivities, higher than 1000 (ohm.m), which indicate a rock of igneous composition, mainly between 15 and 5 m.

Figure 13 ER-1 - 2D Electrical Imaging (TECGEO 2019).

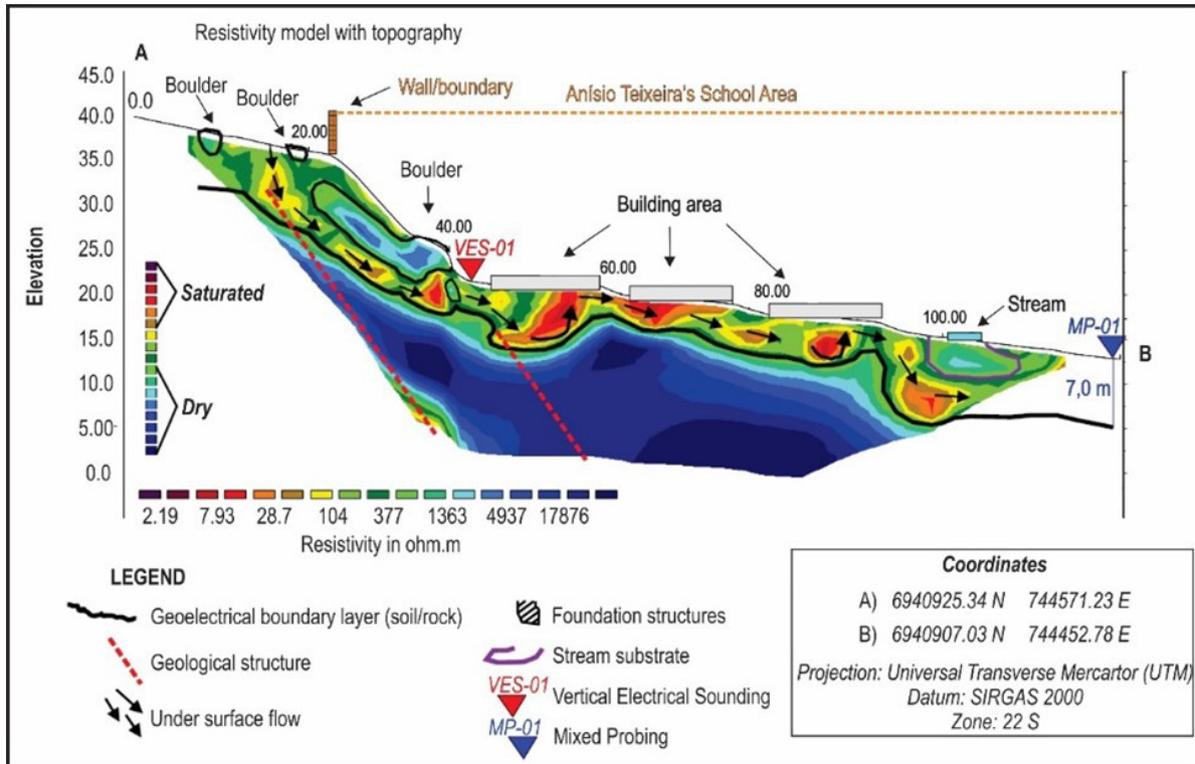
It is identified the blocks, upstream of the classrooms that have cracks, through geophysics (Figure 14).

Figure 14 ER-2 - 2D Electrical Imaging (TECGEO 2019).

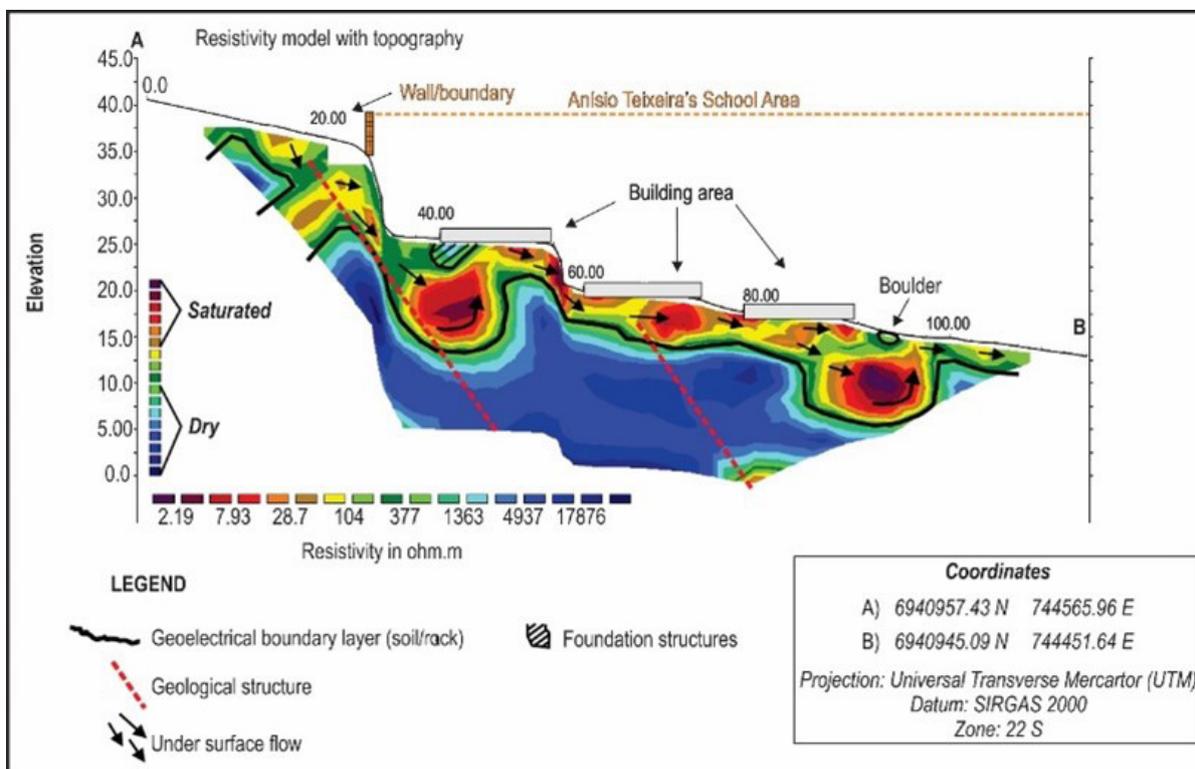
Figure 15 ER-3 - 2D Electrical Imaging (TECGEO 2019).
