Corrosion failures of austenitic and duplex stainless steels in a biodiesel plant

The neutralization of catalysts with hydrochloric acid is an important step in a biodiesel process which generates steel corrosion due to the decrease in pH, and the addition of chlorides in the medium. Other factor responsible for corrosion and consequently failures is the poor miscibility between biodiesel and acid water generating a heterogeneous coverage of the surface of the pipelines and equipment by biodiesel and acid water, presence of galvanic cells and localized corrosion. In this paper, corrosion failures of AISI 316L and 904L austenitic stainless steels (SS), and of SAF 2205, 2507 duplex SS in a biodiesel plant were identified and studied. The low pH, presence of chlorides, high thermal input in welding, temperature gradient and mainly proximity to the acid injection site play the major roles in corrosion which generate the studied failures. Corrosion failures occurred in pipes transporting biodiesel and acid water, in a spool of acid water injection, in a static biodiesel mixer with acidic water, in a cylindrical decanter vessel, and in heat exchangers.

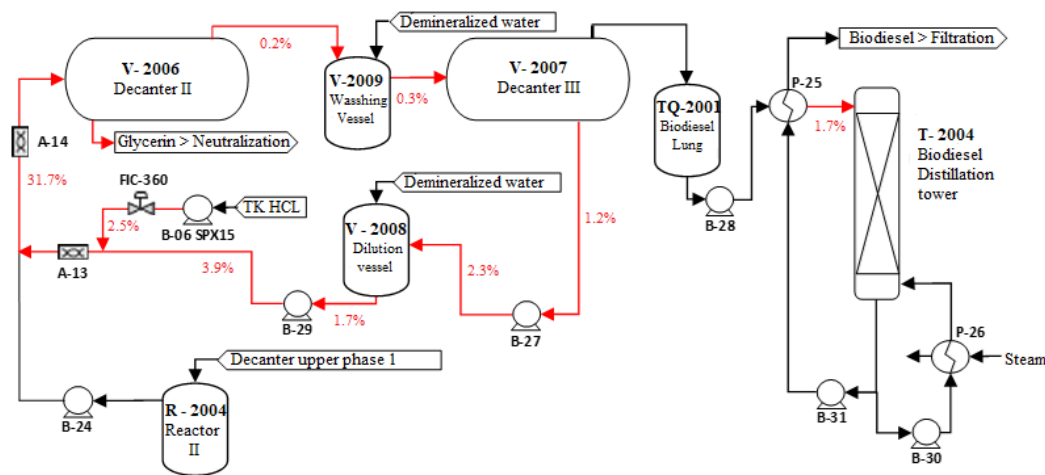
Figure 1: Flowchart with the percentage of failures of each section of the biodiesel circuit.

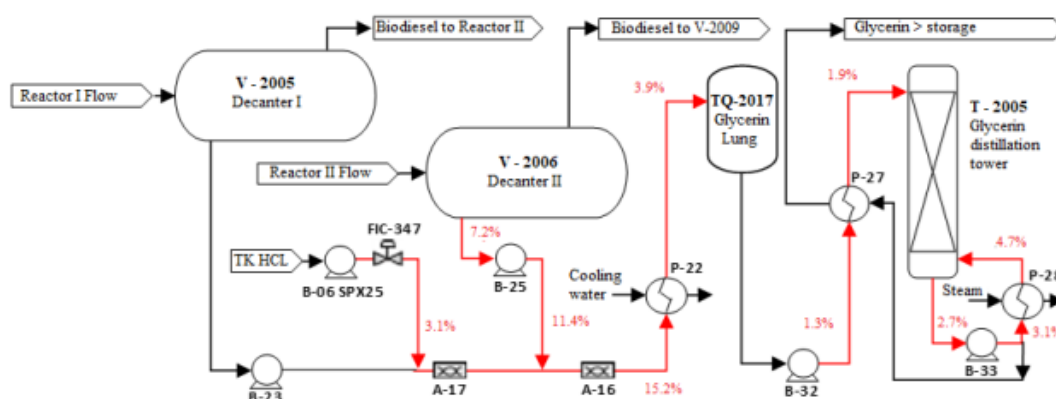
Figure 2: Flowchart with the percentage of failures of each section of the glycerin circuit.

In both circuits, there is a clear trend of decreasing the percentage of failures as the distance of the hydrochloric acid solution dosage points increases. In the biodiesel circuit, 83.7% of the failures occurred in the pipelines immediately connected to the dosing point. In the glycerin circuit, the percentage was 54.5%. The lower percentage in the glycerin circuit is related to the effect of the temperature in the corrosive process, as 19.3% of the failures of this circuit occurred at the reflux of the P-28 exchanger, where the temperature is approximately 95°C, significantly higher than 69 °C from the region close to the acid dosage.
