## Improved testing procedures to assess the physical and mechanical properties of ceramic blocks

In Brazil, ceramic blocks have a significant share of the masonry construction market. Thus, an experimental testing program was devised to determine the physical and mechanical properties of ceramic blocks from different regions of Brazil. The experimental program included blocks from five Brazilian states and ten different producers, and the properties studied were absorption, material density, efflorescence, abrasion, compressive strength, and resistance to wet-dry cycles. The purpose of determining these material properties is to set guidelines to standardize the performance of same-geometry blocks. The material density test method and the wet- and dry cycle test method are being proposed as new tests and are not usually specified in international codes. The objective of the wet and dry cycle test is to determine a durability parameter for blocks that are not subjected to freeze-thaw cycles. The analysis of the results identified important relationship between these properties.

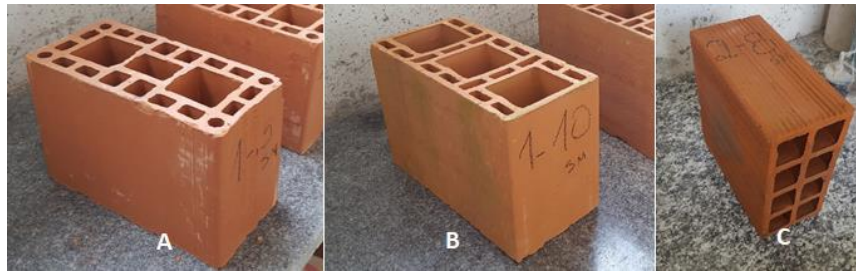
**Figure 1:** Types of blocks tested in research.

Structural hollow wall blocks, shown in Figure 1A; non-structural blocks with vertical hollows, shown in Figure 1B; and non-structural blocks with horizontal hollows, shown in Figure 1C; were tested.

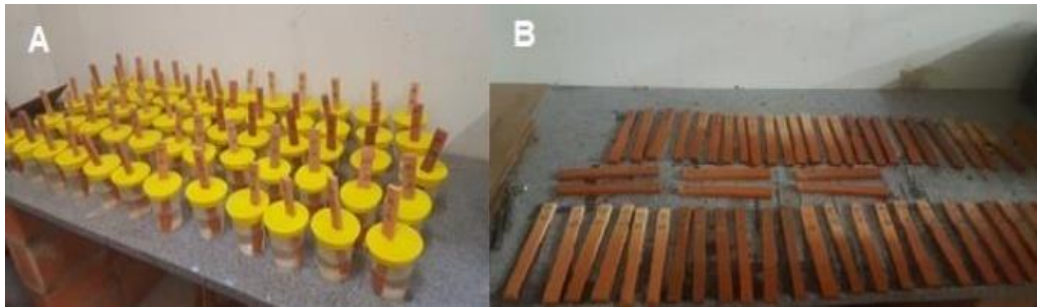
**Figure 2:** A) ready samples and B) extracted prisms

The efflorescence tests were conducted using two procedures: the Franco method [31] and that of the ASTM C67 [15]. In the first procedure, six 2-cm wide by 20-cm high prisms were extracted from six blocks from each producer as shown in Figure 2. These prisms were incubated for 24 hours and then placed for 5 days in cups (200 ml capacity) with distilled water to a depth of 5 cm. The cups were covered using a rubber membrane and placed in a ventilated environment.

The specimens were supervised daily to refill the water, if necessary, and to identify possible cases of efflorescence, especially on the parts of the prism exposed to ventilation. After the 5 days period, the samples were removed from the cups and placed in an oven for 24 hours, after which, they were visually inspected for efflorescence.

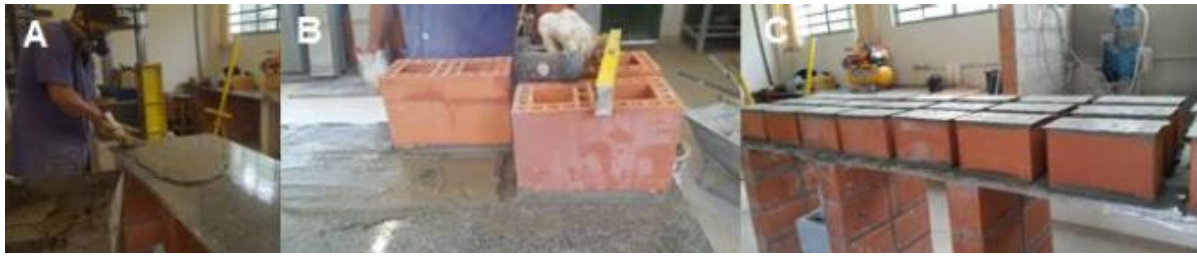
**Figure 3:** A) Mortar preparation, B) block levelling and C) capped blocks.

The test was conducted using the methodology presented in ABNT NBR 15270 [14]. A set of 13 specimens from each producer was tested. The first step of the test was to cap the samples, to level the top and bottom faces of the blocks, using a water-moistened cementitious paste prepared over a plastic film, as shown in Figure 3A (a transparent plastic film is present over the granite top). The samples were placed on top of the paste, as shown in Figures 3B and 3C. The process was repeated for the other face of the block.

After the cap dried, the samples were immersed in water for 6 hours. The saturated specimens were then tested to compression loading.

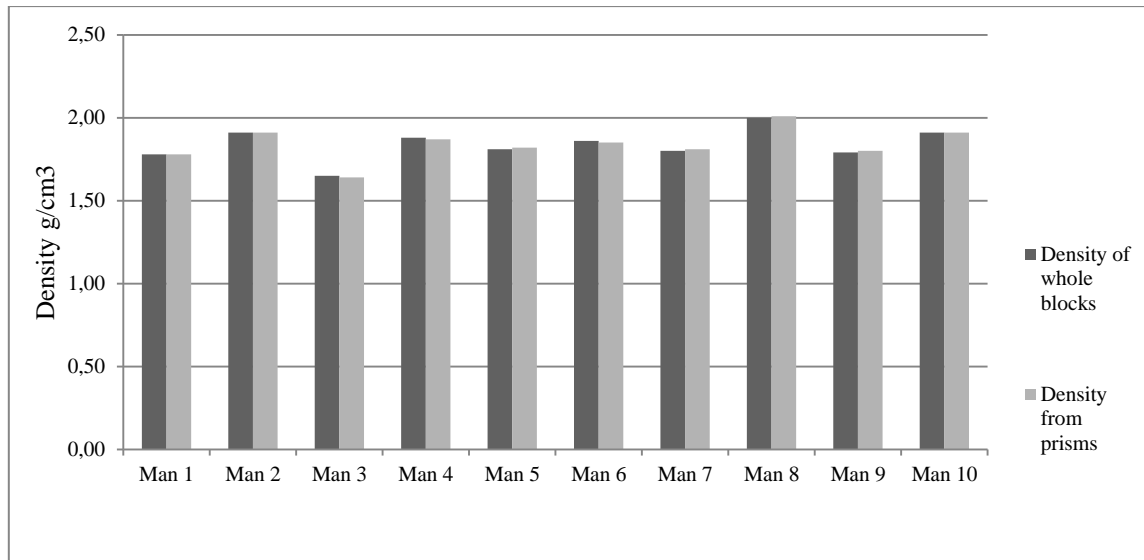
**Figure 4:** Density of whole blocks and density from prisms.

Figure 4 shows the results of the paraffin-free density tests performed on prisms taken from the block face shells and density of the entire block. The results show that there is very little difference between the values obtained using the entire block and that using the prisms.

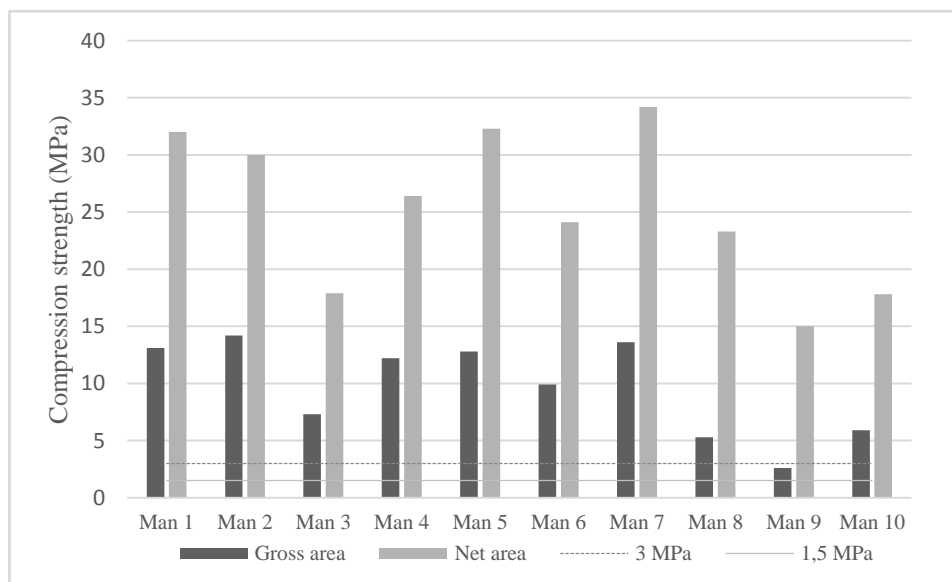
**Figure 5:** Compression strength: gross area vs area net

There is a large dispersion in the results but the blocks from producers 03, 06, 08 and 09 have lower dispersion values. All tested structural blocks, of all producers, have compressive strengths calculated using gross area above 6 MPa and all non-structural blocks have compressive strengths above 2 MPa; these are higher than the recommended by ABNT NBR 15270 which are 3 MPa for structural blocks and 1.5 MPa for non-structural blocks. These results can also be seen in Figure 5.

The structural blocks from producers 01 to 07 have gross to net area ratio between 39.10 and 47.33, while non-structural blocks from producers 08, 09 and 10 have gross to net area ratio between 17.33 and 33.14.

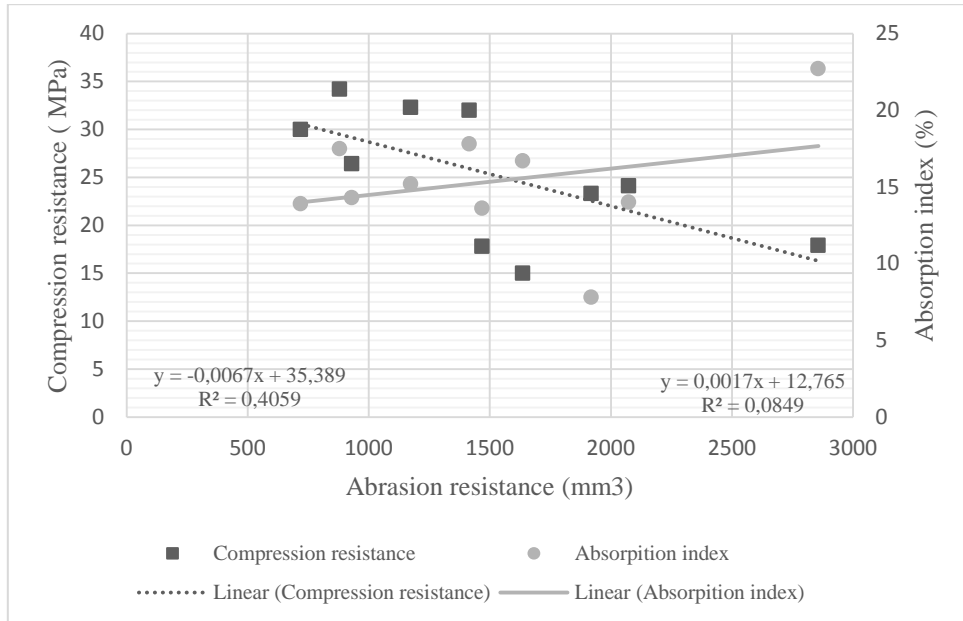
**Figure 6:** Relationship between abrasion resistance vs compression vs absorption.

The relationships among abrasion resistance, compressive strength calculated using the net area, and initial absorption index are shown in Figure 6. These results appear to indicate that there is no proportionality relationship between these properties.

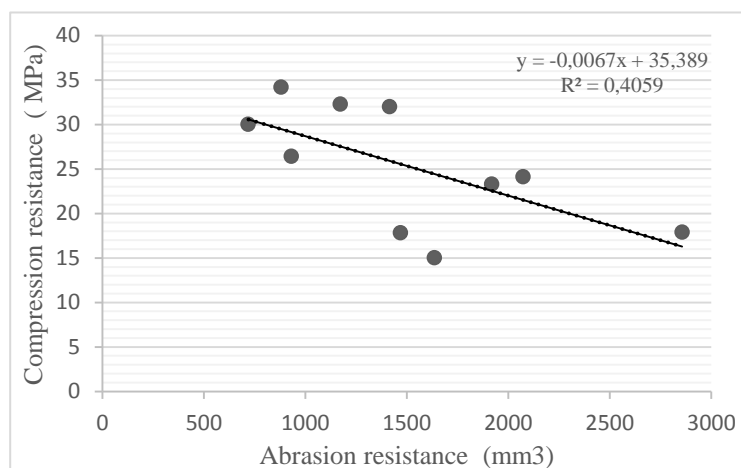
**Figure 7:** Relationship between abrasion resistance vs compression.

An statistical analysis was conducted to verify the linear correlation among the results of these tests and a relationship among them was observed, especially between abrasion resistance and compressive strength, with a correlation coefficient calculated at -0,6371, which indicates that the closer to -1 or 1 the greater the trend of linear correlation between the results analyzed, as shown in Figure 7.

The value tending to - 1 means that the graph of resistance to abrasion vs resistance to compression will be closer to a straight line, showing the inversely proportional relationship between these two variables.

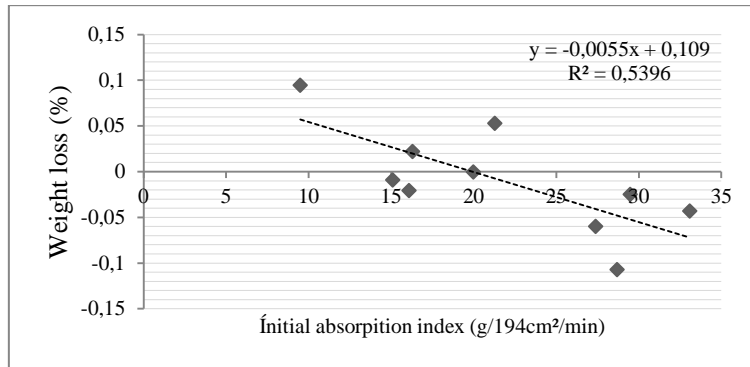
Figure 8: Relationship between initial absorption x mass loss.

A strong relationship was also observed between the initial absorption index and mass loss, obtained from the wet and dry cycle test, with a linear correlation coefficient of 0,7345. This relationship is presented in Figure 8. The results show that the higher the initial absorption index, the smaller the percentage ratio of mass loss.

There is an inverse relationship between the initial absorption index and mass loss, where the higher the initial absorption index the lower the mass loss. Similar relationship exists between absorption in cold or hot water and mass loss, howbeit, slightly stronger for absorption in cold water.

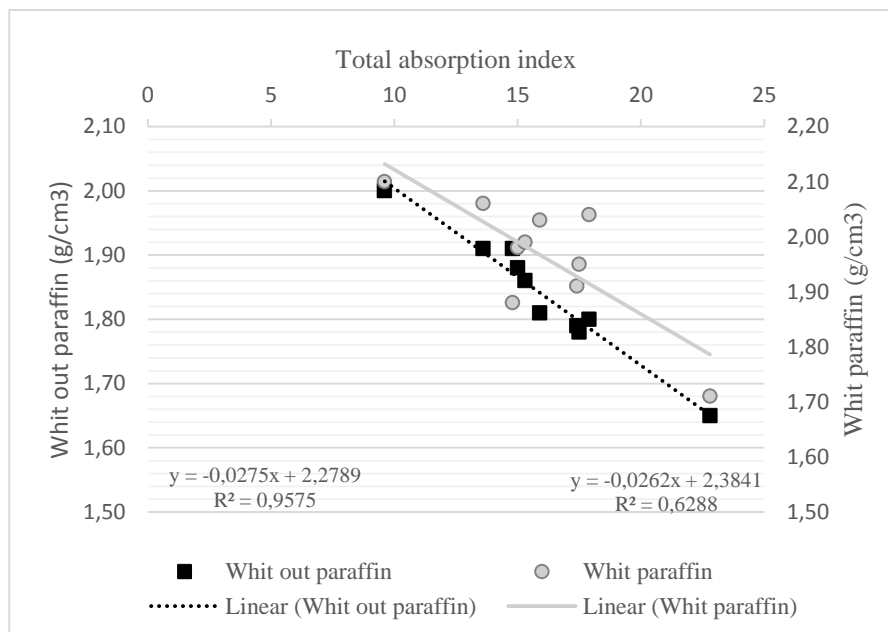
Figure 9: Relationship between total absorption index vs whit out paraffin and whit paraffin.

The density results with and without paraffin had a stronger relationship with the total absorption index than with the initial absorption. It was observed that blocks with higher absorption levels have lower densities and blocks with lower absorption levels have higher densities, as shown in Figure 9.

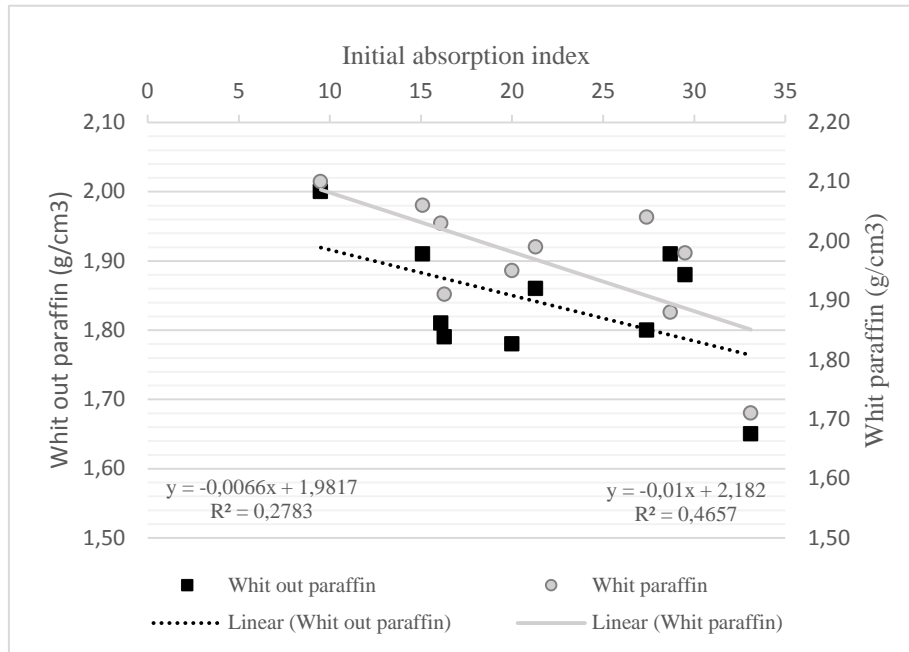
**Figure 10:** Relationship between initial absorption index vs whit out paraffin and whit paraffin.

The same behavior was observed in relationship with initial absorption; i.e., blocks with higher densities have lower initial absorption levels and blocks with lower densities have lower initial absorption levels, as shown in Figure 10.
